Annual Inspection Report - 2021

For Compliance with the EPA Coal
Combustion Residuals (CCR) Rule
40 CFR §257.83(b)

Erickson Power Station –
Forebay, Retention Basin, and
Clear Water Pond

April 27, 2022

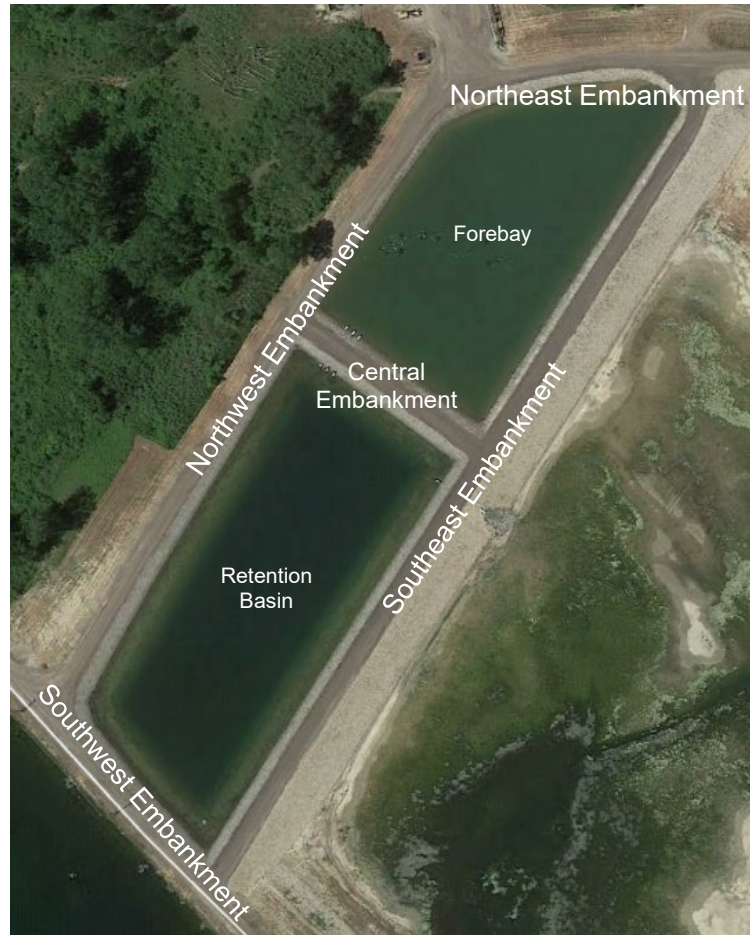
Figure 4. Forebay and Retention Basin Embankment Terminology

The Southeast Embankment separates the Forebay and Retention Basin to the northwest and the Former Impoundment, which is closed, to the southeast. The Southeast Embankment appeared to be in good condition and no evidence of movement, settlement, cracking, distress, erosion, seepage, animal burrows or other adverse conditions was observed in the crest and upstream and downstream slopes.

- The crest of the embankment consisted of a gravelly/soil surface. Minor rutting of the crest was observed.
- Rip-rap protects the interior and exterior slopes, which was in good condition.
- Vegetation has been maintained properly since the previous inspection.
- The vents installed as part of the liner system were visible, appeared to be in good condition, and were free of debris.

The Northeast Embankment separates the Forebay to the southwest and the Hydro-Bins and grassy areas to the north. The Northeast Embankment appeared to be in good condition, and no evidence of movement, settlement, cracking, distress, erosion, seepage, animal burrows or other adverse conditions was observed.

- Riprap protects the interior slope. The crest of the embankment consisted of a gravelly/soil surface. The crest and slopes appeared to be in good condition.
- Vegetation has been maintained properly since the previous inspection.

The Northwest Embankment separates the Forebay and Retention Basin to the southeast and wooded areas to the northwest. The Northwest Embankment appeared to be in good condition, and no evidence of movement, settlement, cracking, distress, erosion, seepage, animal burrows or other adverse conditions was observed in the crest and upstream and downstream slopes.

- Riprap protects the interior slope. The crest of the embankment consisted of a gravelly/soil surface. The crest and slopes appeared to be in good condition.
- The vents installed as part of the liner system were visible, appeared to be in good condition, and were free of debris.
- Vegetation has been maintained properly since the previous inspection.

The Southwest Embankment separates the Retention Basin to the northeast and Lake Delta to the southwest. The Southwest Embankment appeared to be in good condition, and no evidence of movement, settlement, cracking, distress, erosion, seepage, animal burrows or other adverse conditions was observed in the crest and upstream and downstream slopes.

- Riprap protects the interior slope and vegetation covers the exterior slope (adjacent to Lake Delta). The crest of the embankment consisted of a gravelly/soil surface. The crest and slopes appeared to be in good condition.
- Vegetation has been maintained properly since the previous inspection.

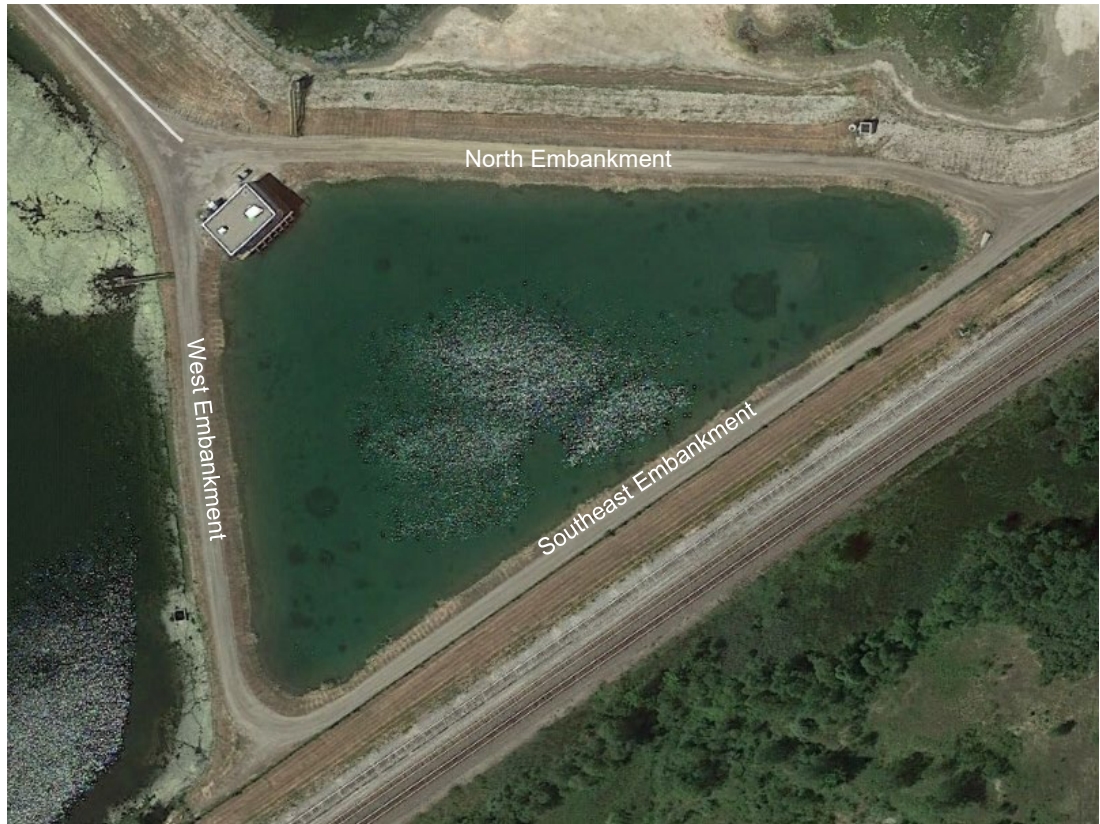
Figure 6. Clear Water Pond Embankment Terminology

The Southeast Embankment separates the Clear Water Pond to the northwest and the swale and railroad to the southeast. The Southeast Embankment appeared to be in good condition and no evidence of movement, settlement, cracking, distress, erosion, seepage, or other adverse conditions was observed in the crest and upstream and downstream slopes.

- The crest of the embankment consisted of a gravelly/soil surface. Minor rutting of the crest was observed.
- Riprap protects the interior and exterior slopes, which was in good condition.
- There are several small diameter trees that are growing along the fence at the crest.
- Vegetation appears to have been maintained properly on both slopes of the embankment and at the exterior toe in the swale.

- A few small animal burrows were observed on the exterior slope of the embankment, outside of the fence.

The North Embankment separates the Clear Water Pond to the south and the Former Impoundment, which is closed, to the north. The North Embankment appeared to be in good condition and no evidence of movement, settlement, cracking, distress, erosion, seepage, animal burrows or other adverse conditions was observed in the crest and upstream and downstream slopes.

- Vegetation appears to have been maintained properly on both sides of the embankment.
- There was evidence of sloughing on the interior slope of the North Embankment which was observed in previous inspections.
- Riprap protects the exterior slope (adjacent to the Former Impoundment) in several areas. The rip-rap extends to the crest of the exterior slope on the eastern portion of the North Embankment, whereas the rip-rap extends to a vegetated bench on the western portion of the North Embankment.
- The crest of the embankment consisted of a gravelly/soil surface. No evidence of movement, settlement, cracking, or other distress was observed in the crest other than minor rutting.

The West Embankment separates the Clear Water Pond to the east and Lake Delta to the west. The West Embankment appeared to be in good condition and no evidence of movement, settlement, cracking, distress, erosion, seepage, animal burrows or other adverse conditions was observed in the crest and upstream and downstream slopes.

- Vegetation appears to have been maintained properly on both sides of the embankment.
- The crest of the embankment consisted of a gravelly/soil. No evidence of movement, settlement, cracking, or other distress was observed in the crest.
