Annual Inspection Report - 2025

For Compliance with the EPA Coal
Combustion Residuals (CCR) Rule
40 CFR §257.83(b)

Former Erickson Power
Station – Former Forebay,
Former Retention Basin, and
Former Clear Water Pond

February 20, 2025

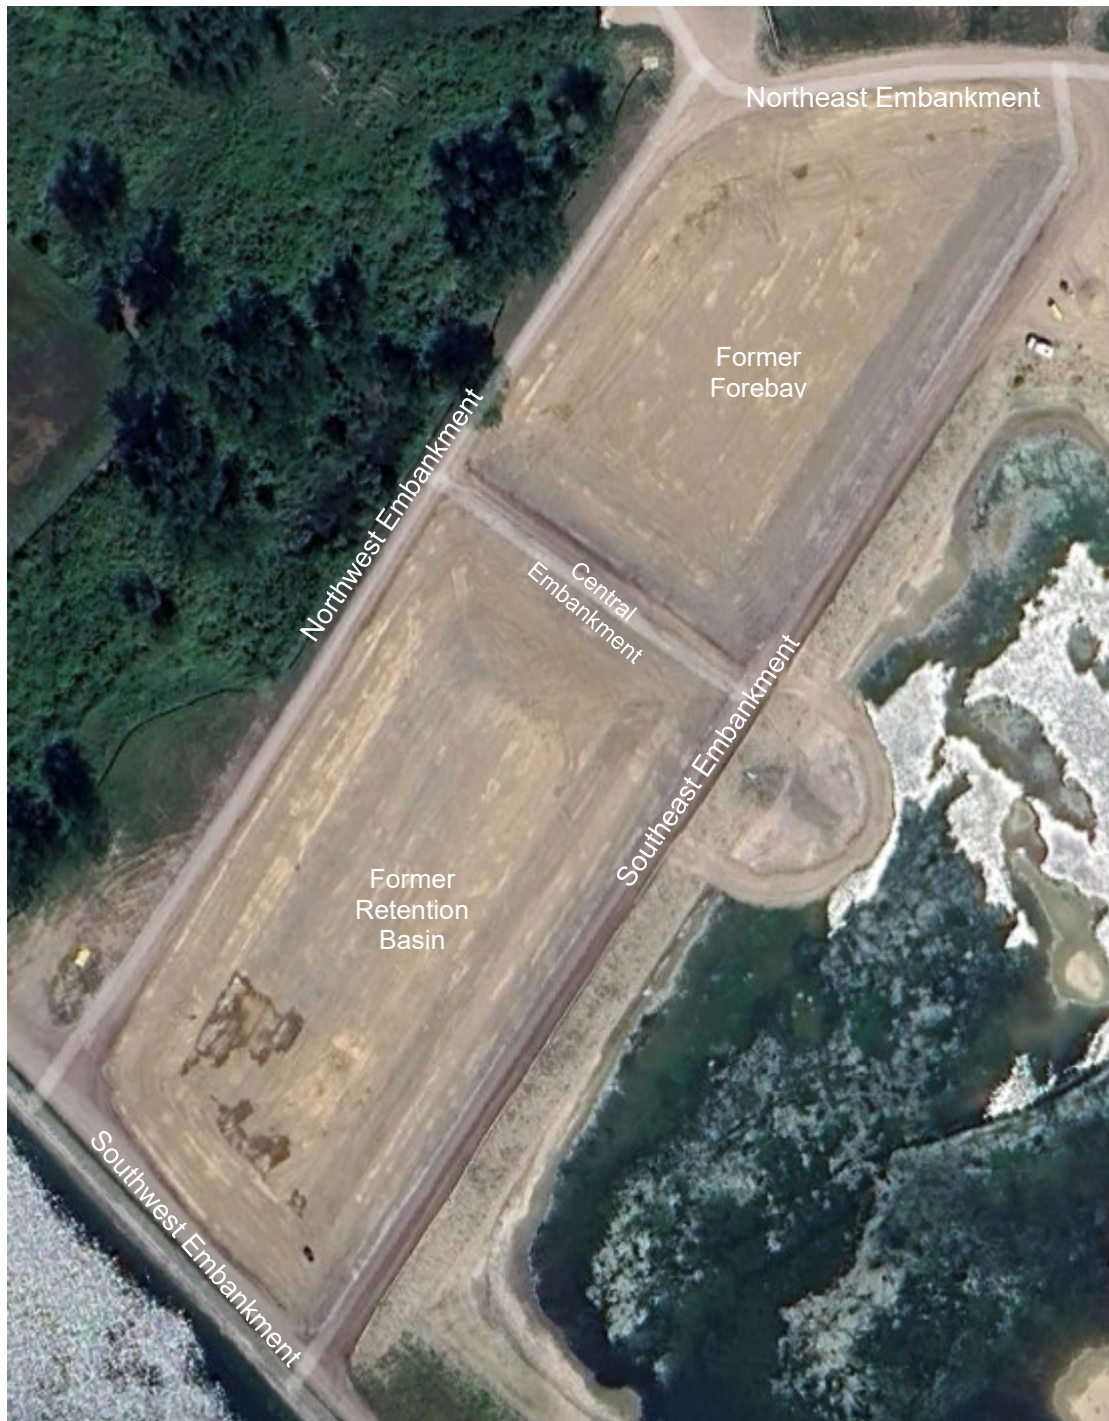
Figure 3. Former Forebay and Former Retention Basin Embankment Terminology

The Southeast Embankment separates the Former Forebay and Former Retention Basin to the northwest and the Former Impoundment to the southeast. As previously stated, all impoundments at the site are closed and CCR has been removed. The Southeast Embankment appeared to be in good condition and no evidence of movement, settlement,

cracking, distress, seepage, animal burrows or other adverse conditions was observed in the crest and upstream and downstream slopes.

The Northeast Embankment separates the Former Forebay to the southwest and the Hydro-Bins and grassy areas to the north. The Northeast Embankment appeared to be in good condition, and no evidence of movement, settlement, cracking, distress, seepage, animal burrows or other adverse conditions was observed.

The Northwest Embankment separates the Former Forebay and Former Retention Basin to the southeast and wooded areas to the northwest. The Northwest Embankment appeared to be in good condition, and no evidence of movement, settlement, cracking, distress, seepage, animal burrows or other adverse conditions was observed in the crest and upstream and downstream slopes.

- Erosion is present on the interior embankment where CCR removal occurred and no vegetation is present. This condition is temporary as the Former Forebay and Former Retention Basin will be filled with soil now that the CCR removal is complete.

The Southwest Embankment separates the Former Retention Basin to the northeast and Lake Delta to the southwest. The Southwest Embankment appeared to be in good condition, and no evidence of movement, settlement, cracking, distress, seepage, animal burrows or other adverse conditions was observed in the crest and upstream and downstream slopes.

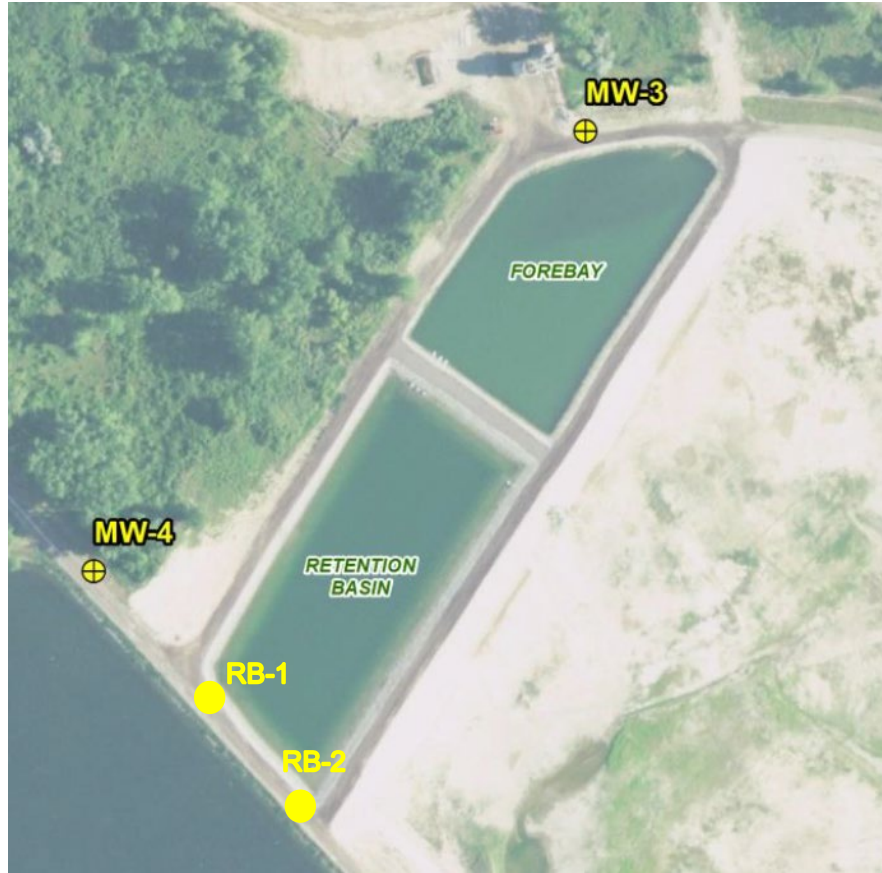
Figure 4. Monitoring Well Locations - Former Forebay and Former Retention Basin

No other instrumentation is present at the Former Forebay and Former Retention Basin.

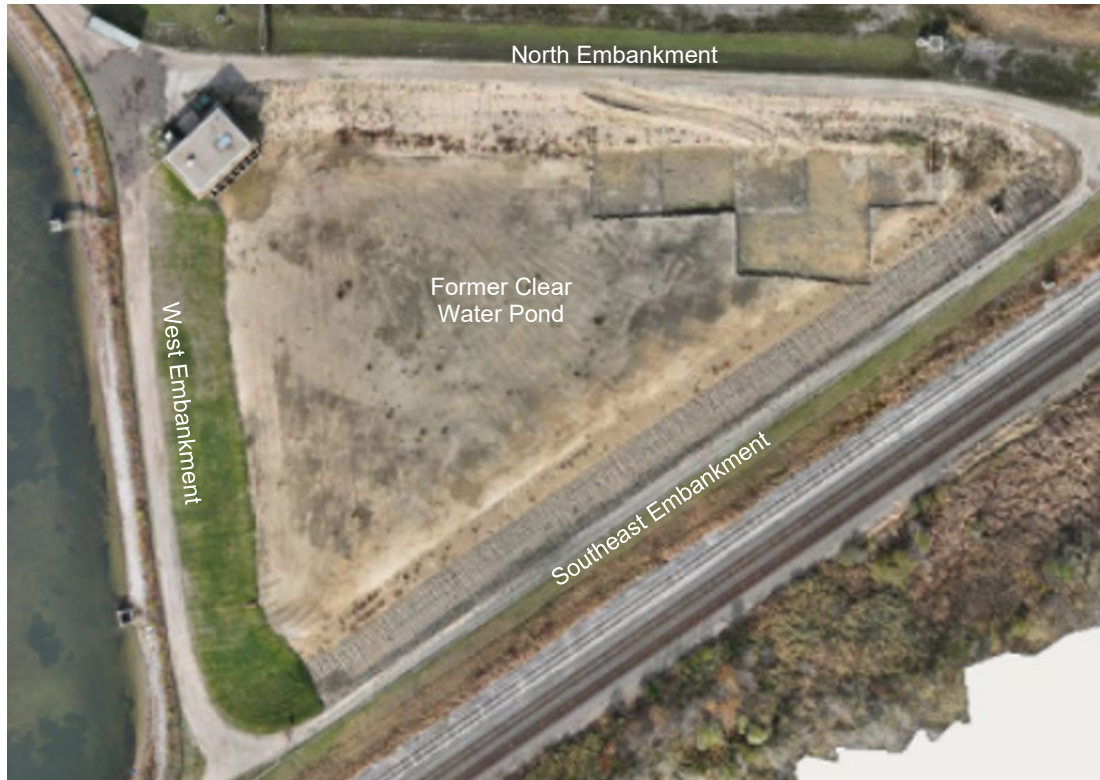
Figure 5. Former Clear Water Pond Embankment Terminology

The Southeast Embankment separates the Former Clear Water Pond to the northwest and the swale and railroad to the southeast. The Southeast Embankment appeared to be in good condition and no evidence of movement, settlement, cracking, distress, seepage, animal burrows or other adverse conditions was observed in the crest and upstream and downstream slopes.

- This embankment has been temporarily restricted of vehicle traffic as a portion of the interior crest has been removed during impoundment decommissioning activities. The interior embankment is currently being resurfaced to reopen the embankment for vehicle traffic.
- The crest of the embankment consisted of a gravelly/soil surface. Minor rutting of the crest was observed.
- Riprap protecting the interior slope has been removed.

- Vegetation has been removed from the interior slope and the vegetation appears to have been maintained properly on the exterior slope of the embankment and at the exterior toe in the swale.
- Erosion is present on the interior embankment where CCR removal occurred and no vegetation is present. This condition is temporary and this embankment will be reseeded.

The North Embankment separated the Former Clear Water Pond to the south and the Former Impoundment to the north. As previously stated, all impoundments at the site are closed and CCR has been removed. The North Embankment has been removed at the time of this inspection.

The West Embankment separates the Former Clear Water Pond to the east and Lake Delta to the west. The West Embankment appeared to be in good condition and no evidence of movement, settlement, cracking, distress, seepage, animal burrows or other adverse conditions was observed in the crest and upstream and downstream slopes.

- Vegetation has been removed from the interior slope and the vegetation appears to have been maintained properly on the exterior slope.
- The crest of the embankment consisted of a gravelly/soil. No evidence of movement, settlement, cracking, or other distress was observed in the crest.
- Erosion is present on the interior embankment where CCR removal has occurred and no vegetation is present. This condition is temporary and this embankment will be reseeded.
