Initial Inspection Report

For Compliance with the EPA Coal
Combustion Residuals (CCR) Rule
40 CFR 257.83(b)

Erickson Power Station – Clear Water Pond

June 12, 2020

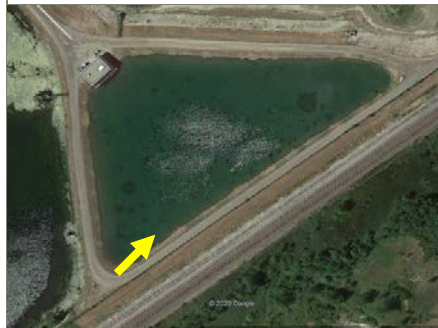
Photograph No. 1	
Description: Interior slope of Southeast Embankment and fence.

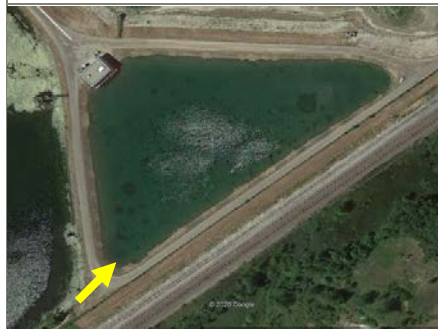
Photograph No. 2	
Description: Monitoring Well 1 (MW-1) installed in 2019.

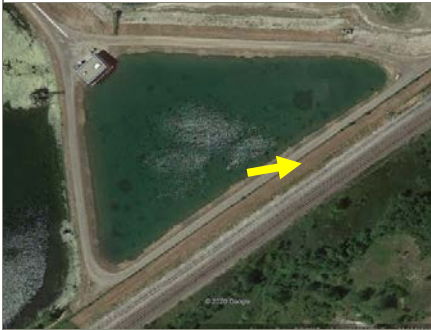
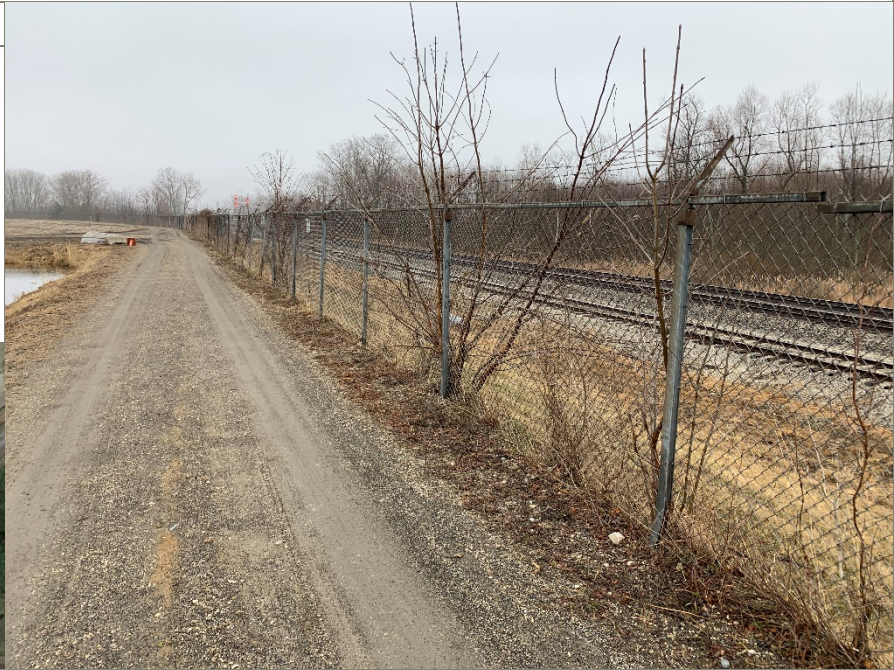
Photograph No. 3

Description:
Exterior slope of Southeast Embankment, fence and Rail Road.

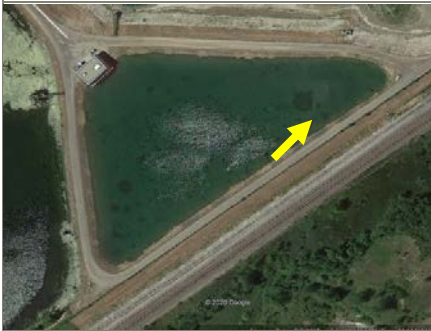
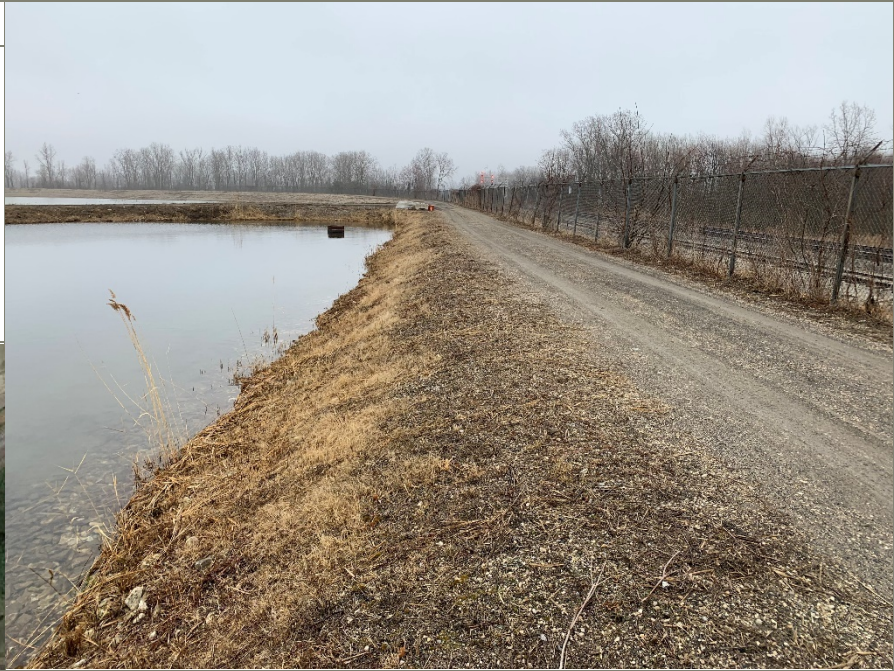
Photograph No. 4

Description:
Interior slope of Southeast Embankment and Emergency Overflow Structure in the distance.

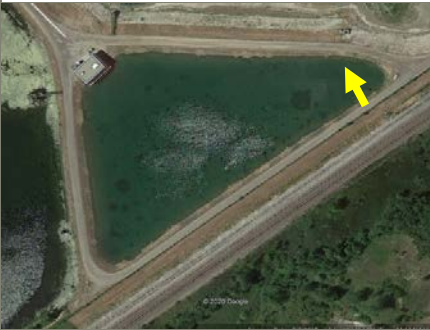
The top of the inlet (Photo 5) of the Emergency Overflow Structure was repaired by BWL (approx. May 2017) due to corrosion/deterioration of the pipe. The outlet pipe appeared in good condition and no leaking, sediment, or flow of water was observed. There was no evidence of settlement, sinkholes, or cracking in the area of the embankment above the pipe extending through the Clear Water Pond embankment.

Photograph No. 5	
Description: Emergency Overflow Structure (inlet). Note welded extension added to the structure to repair leaks.

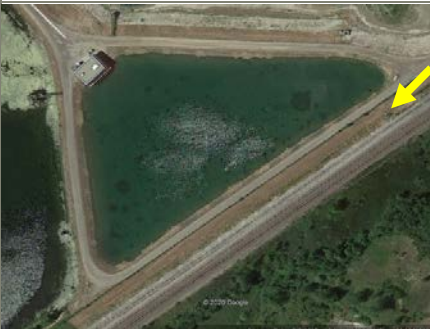
Photograph No. 6	
Description: Exterior slope of Southeast Embankment and Emergency Overflow Structure (outlet).

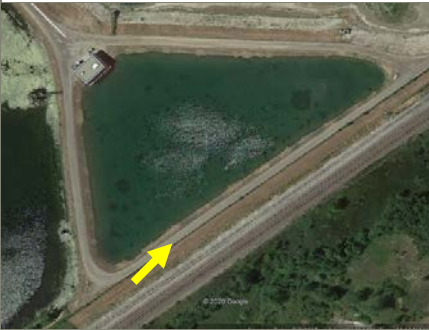
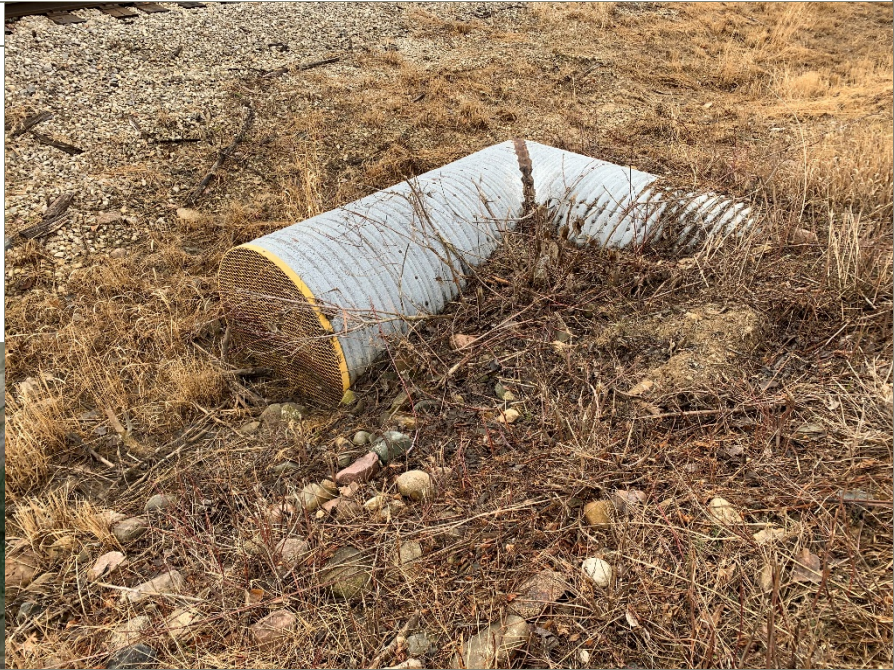
Photograph No. 7

The outlet pipe is equipped with fencing to prevent animals from entering and vegetation was maintained around the outlet. The fencing was installed on the outlet pipe as recommended in the GZA 2012 report (Ref. [2]).

Description:
Emergency Overflow Structure
(outlet).

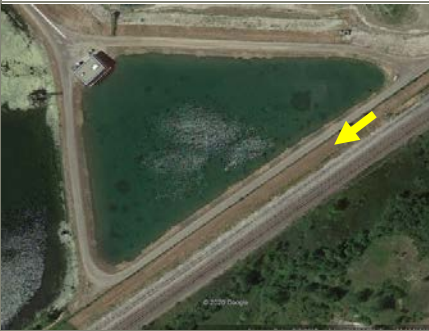
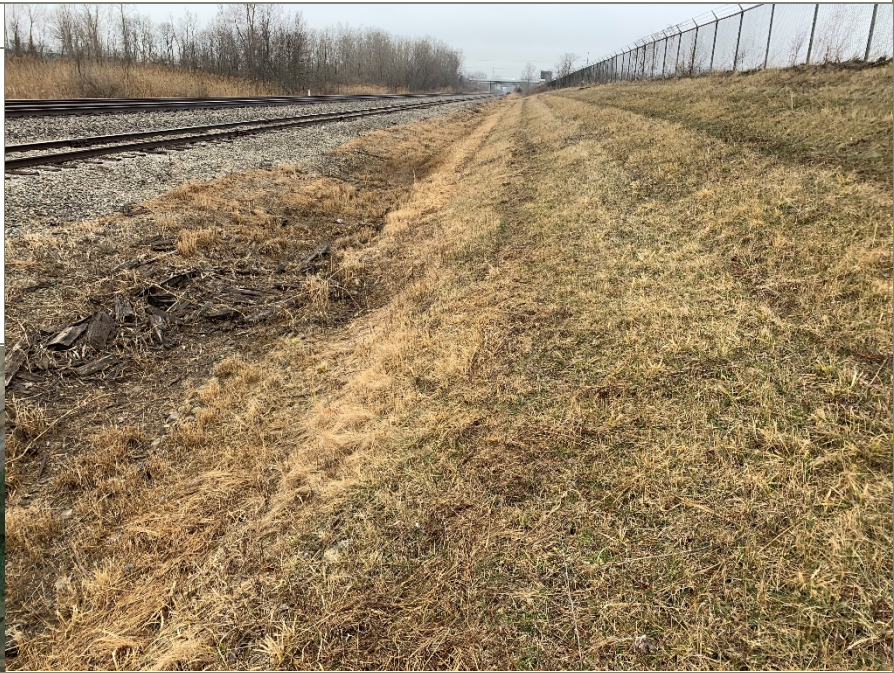
Photograph No. 8

Description:
Exterior slope of Southeast
Embankment.

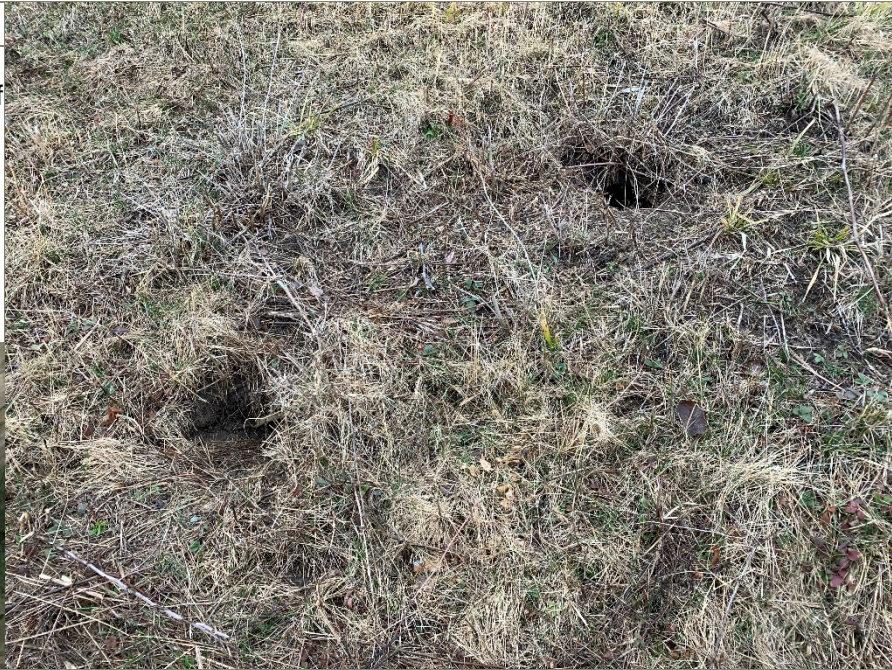
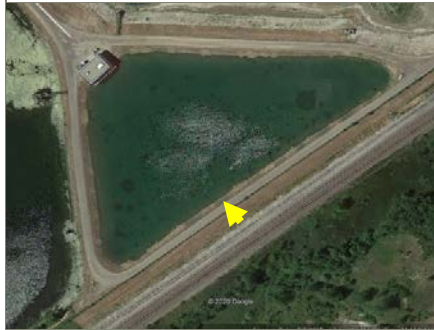
Photograph No. 9

There were a few small animal burrows (Photos 9 and 10). Three burrows were observed on the exterior slope of the embankment, outside of the fence.

Description:
 Animal burrows in exterior slope of Southeast Embankment.

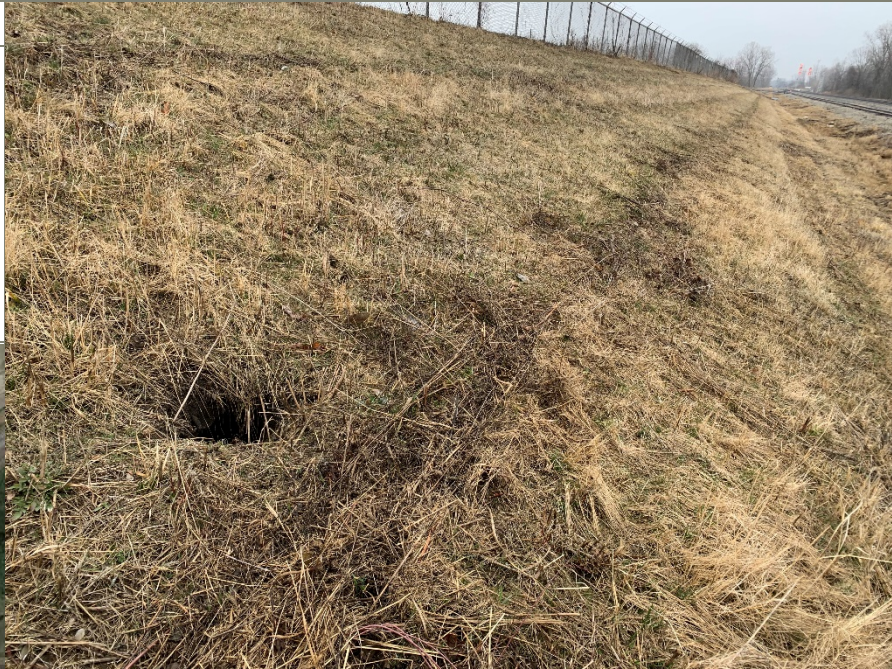
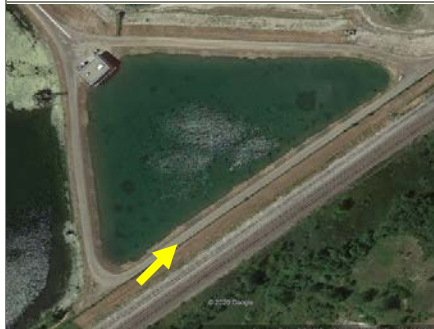
Photograph No. 10

Description:
 Exterior slope of Southeast Embankment. Note animal burrow.

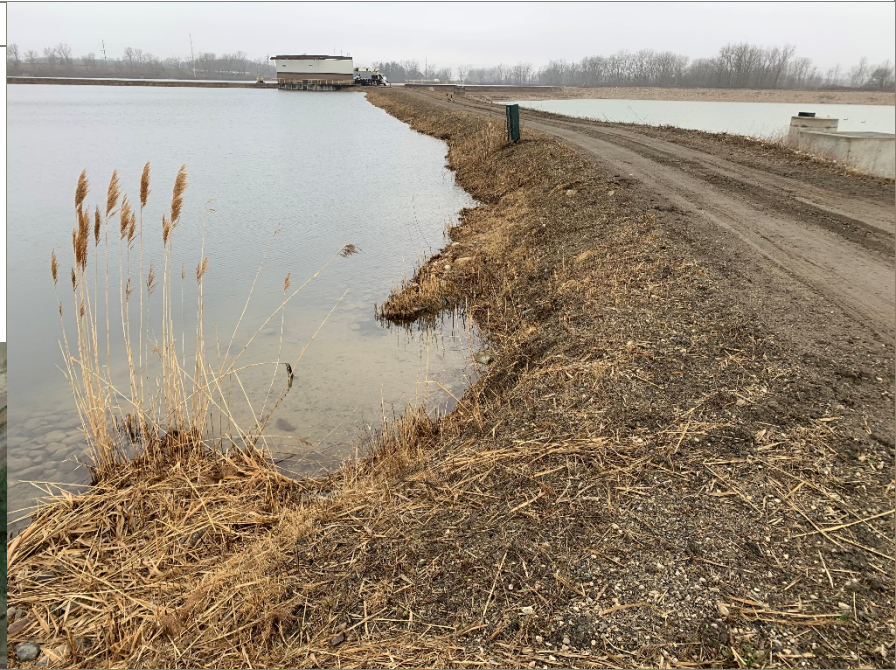
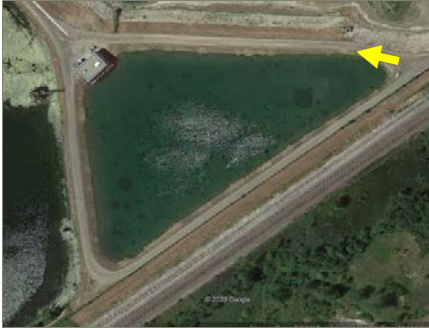
Photograph No. 11

The crest of the embankment consisted of a gravelly/soil surface (Photos 1 through 4). No evidence of movement, settlement, cracking, or other distress was observed in the crest, other than rutting, as seen in Photo 11.

Description:
North Embankment and Pump House in distance. Note sloughing in the interior slope. Note slight elevation drop along crest of North Embankment. Retention Transfer Structure and Old Ash Impoundment Transfer Structure to the right of the photo.

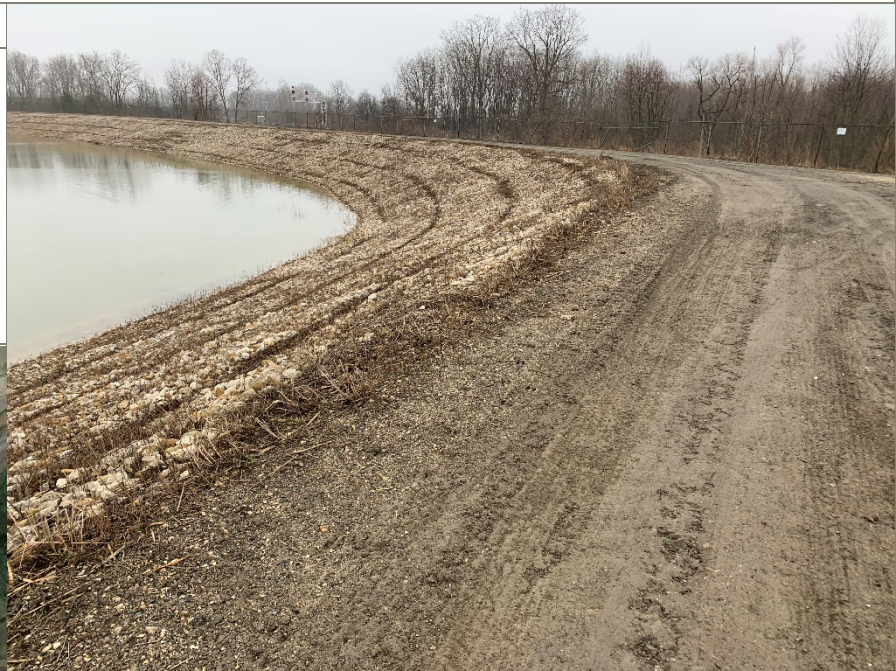
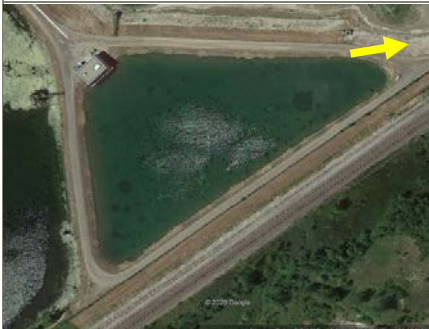
Photograph No. 12

Description:
Exterior slope of North Embankment and water ponding in Former Impoundment. Not rip rap protection.

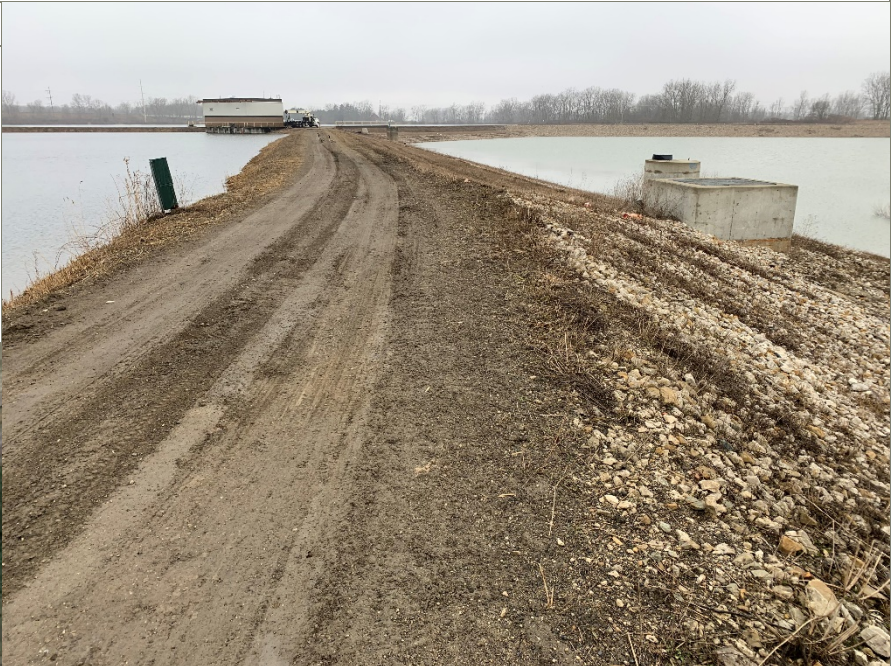
Photograph No. 13

Description:
 North Embankment and Transfer Structure. Retention Transfer Structure and Old Ash Impoundment Transfer Structure to the right of the photo.

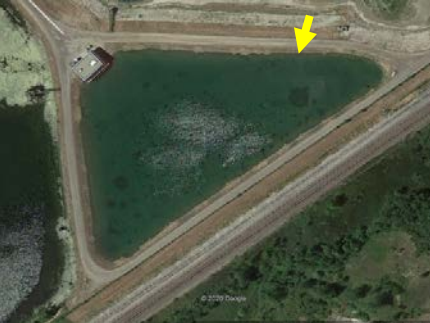
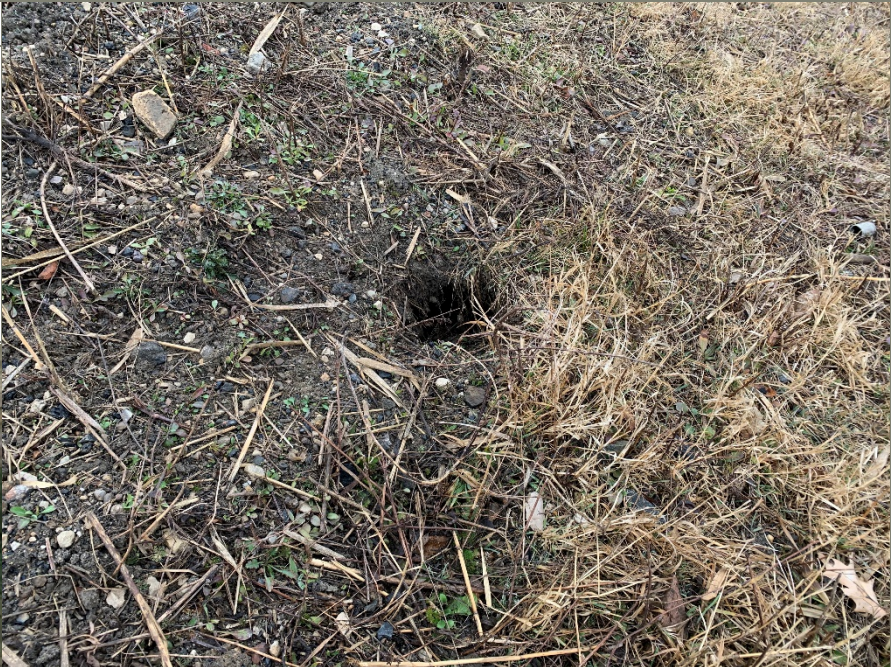
Photograph No. 14

Description:
 Animal burrow in exterior slope of North Embankment.

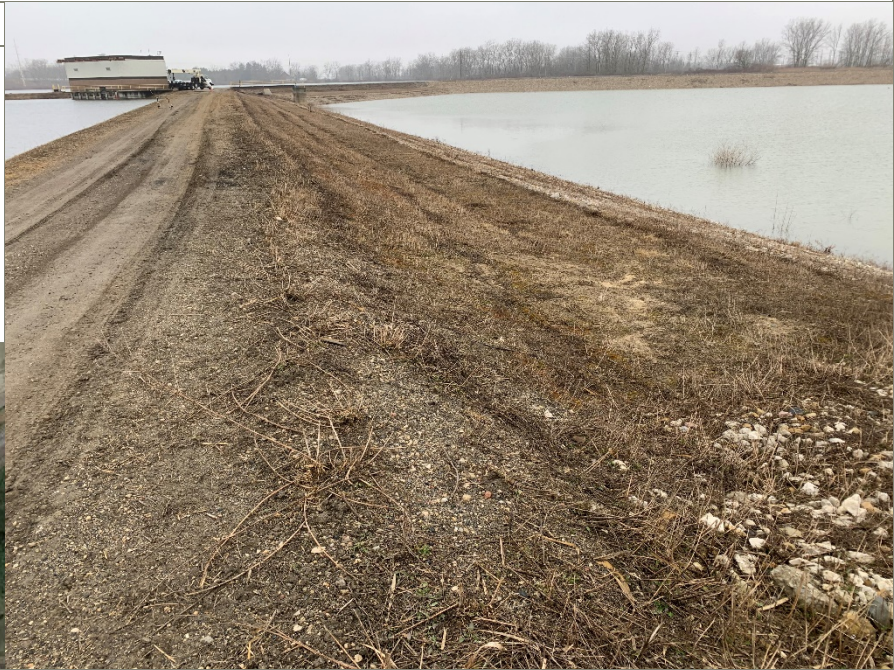
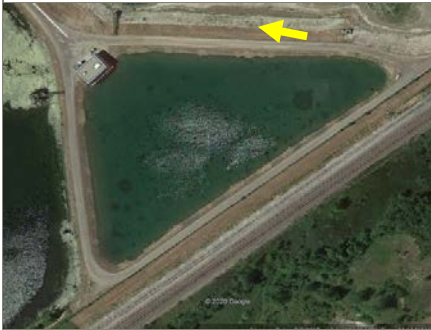
Photograph No. 15

Description:
Exterior slope of North Embankment. Note bench in the exterior slope.

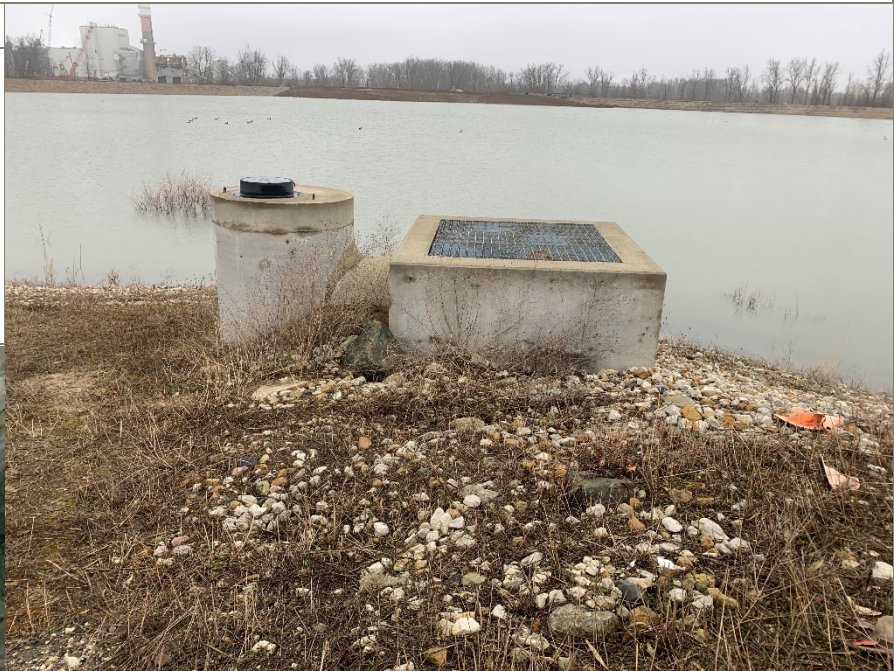
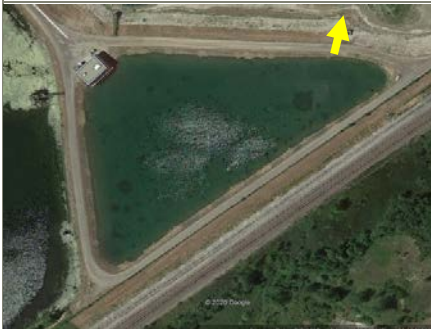
Photograph No. 16

The Old Ash Impoundment Transfer Structure, located between the Clear Water Pond and the Former Impoundment, appeared to be in good condition (Photo 16). Water from the Retention Basin flows through piping to the Retention Transfer Structure, which is then transferred to the Old Ash Impoundment Transfer Structure which then flows to the Clear Water Pond. The piping extending through the Clear Water Pond embankment consists of 36-inch ductile iron pipe, equipped with square, (8-feet x 8-feet) concrete, anti-seep collars. The concrete of the structures appeared to be in good condition. The pipe of the Old Ash Impoundment Transfer Structure is underground/submerged and could not be observed during the visual inspection. There was no evidence of settlement, sinkholes, or cracking in the area of the embankment above the pipe extending through the Clear Water Pond embankment.

Description:
Retention Transfer Structure (Left) and Old Ash Impoundment Transfer Structure (Right) with Former Impoundment in background.

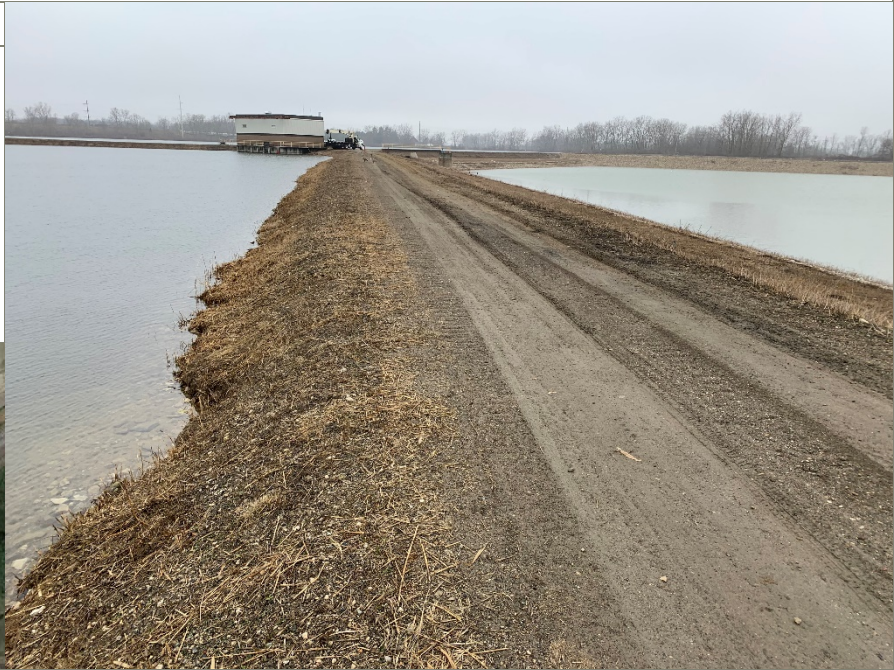
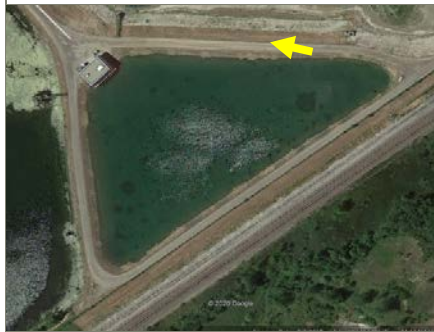
Photograph No. 17

Description:
 Interior slope of North Embankment. Note minor sloughing on interior slope.

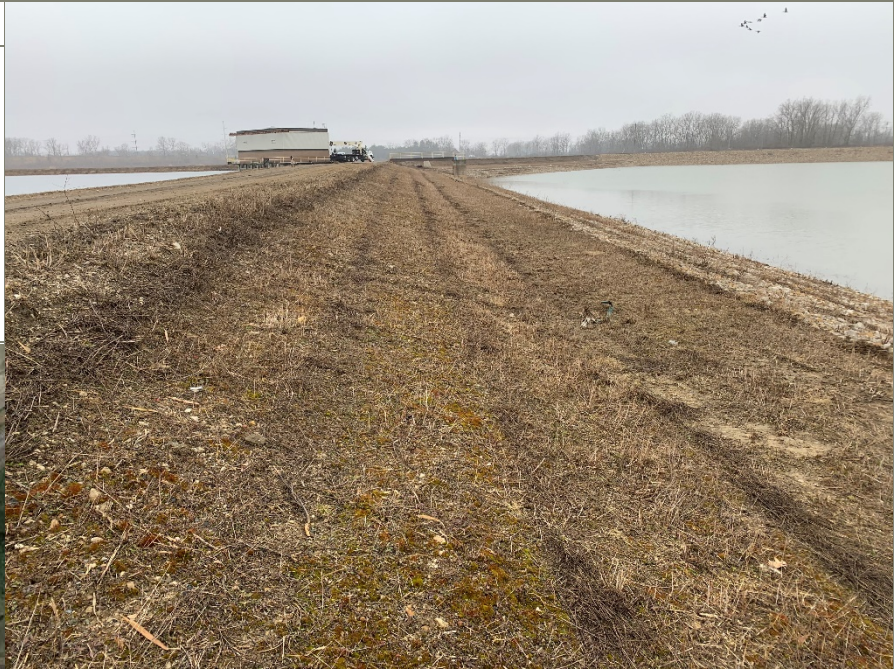
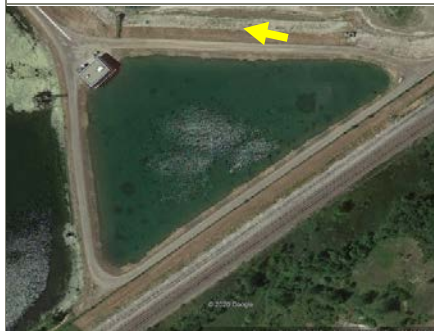
Photograph No. 18

Description:
 Exterior slope bench of North Embankment.

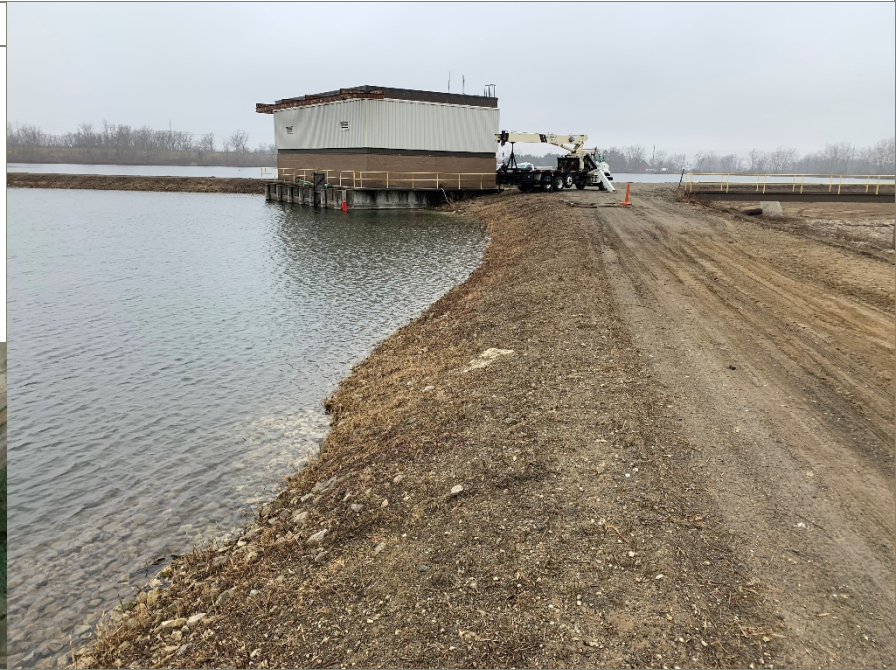
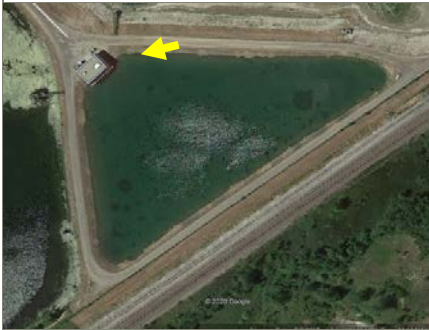
Photograph No. 19

Description:
Interior slope of North Embankment and Pump House.

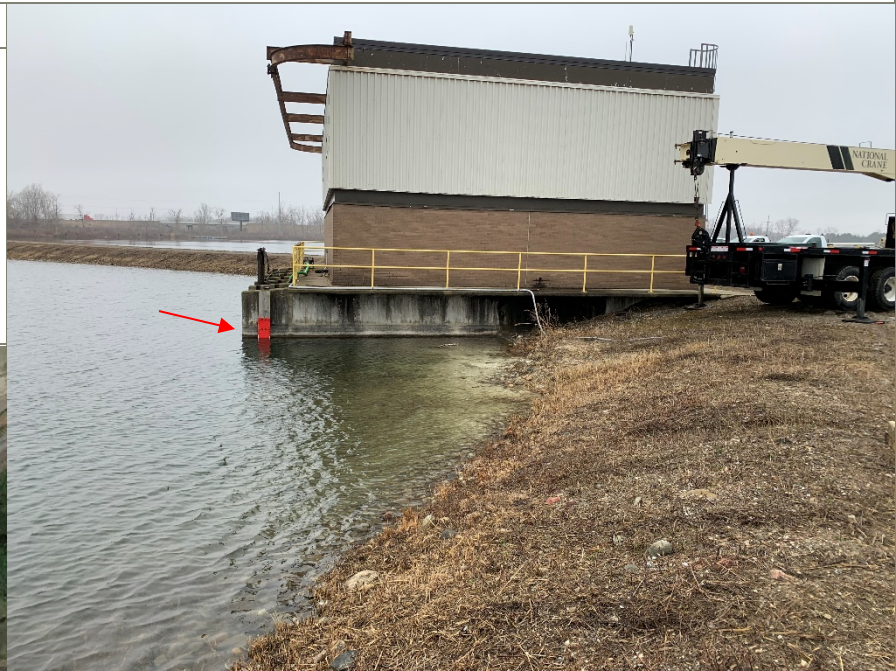
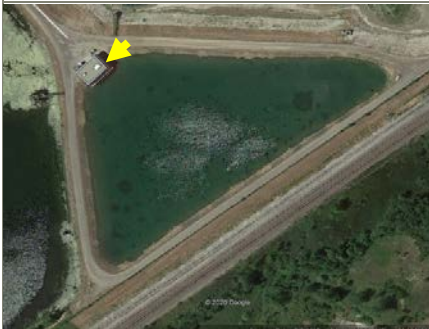
Photograph No. 20

Description:
Pump house. Note red staff gauge attached to Pump House (red arrow identifying gauge).

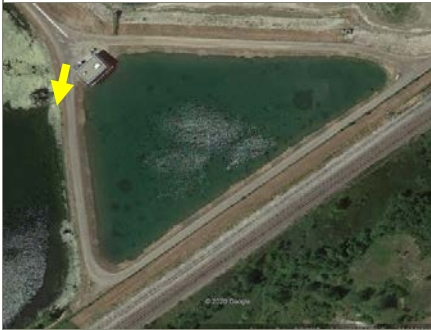
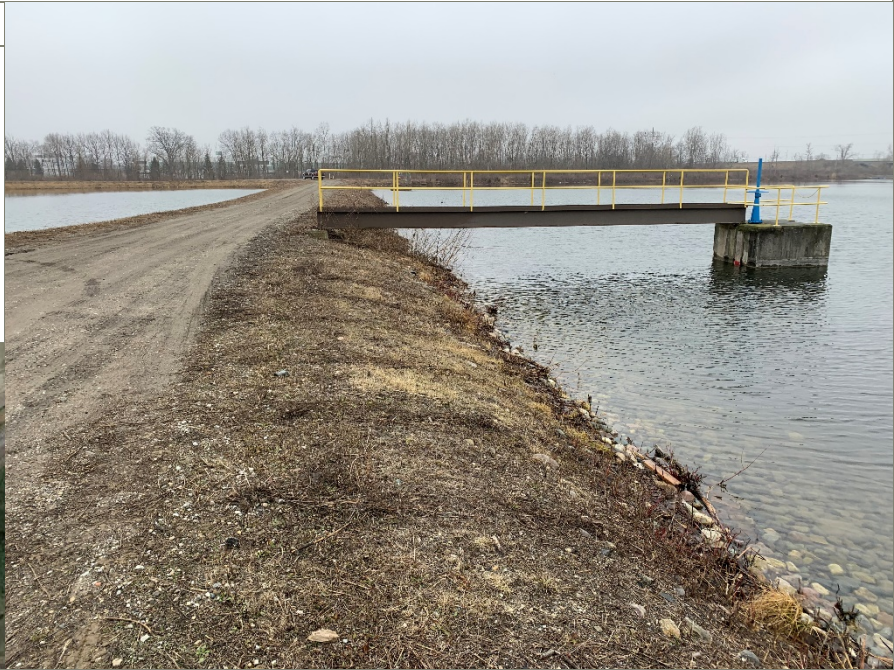
Photograph No. 23

Description:
Exterior slope of West Embankment and Lake Delta Drainage Structure. Lake Delta is to the right of the photograph.

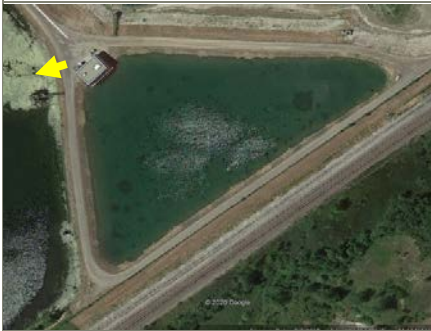
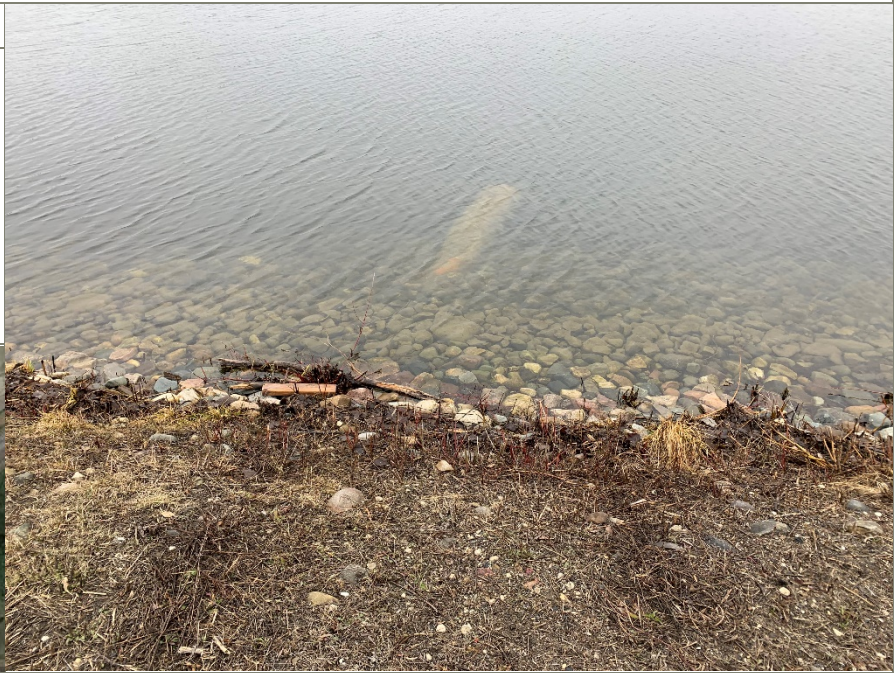
Photograph No. 24

Description:
Submerged pipe outlet in Lake Delta. This pipe is currently active and feeds water via a pump station operated by BWL from Grand River to Lake Delta.

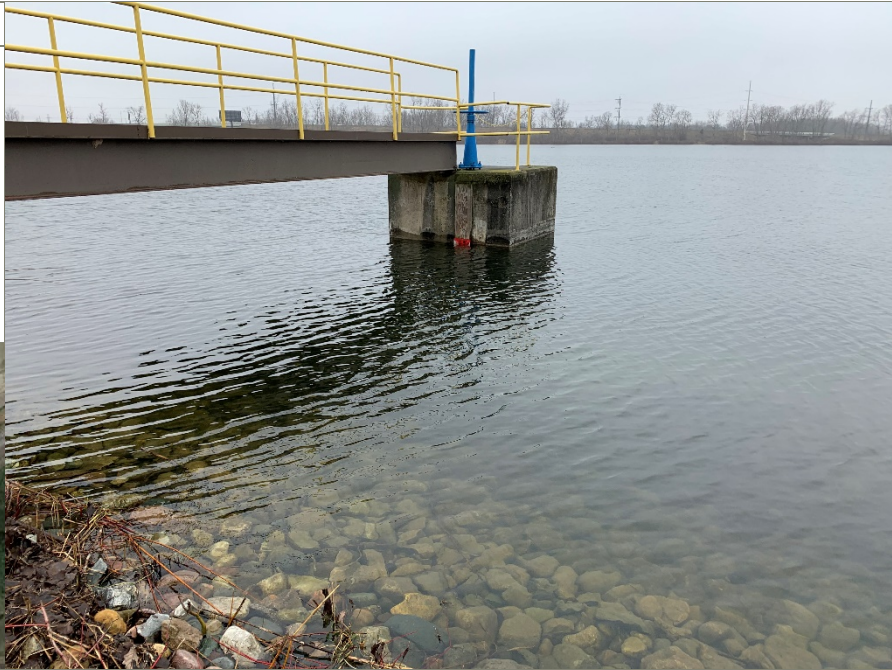
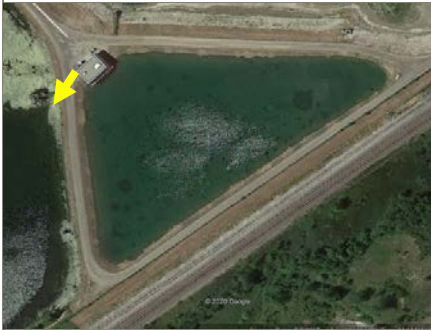
Photograph No. 25

Description:
 Lake Delta Drainage Structure
 and regulating valve.

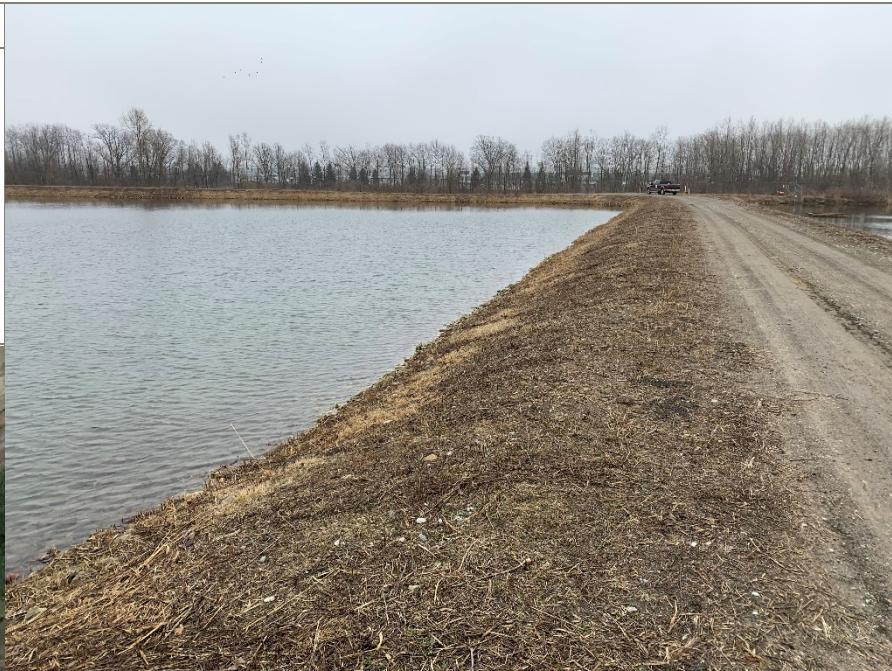
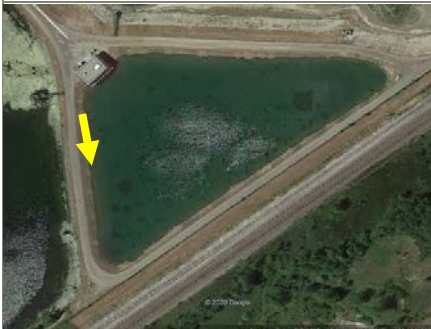
Photograph No. 26

Description:
 Interior slope of West
 Embankment.

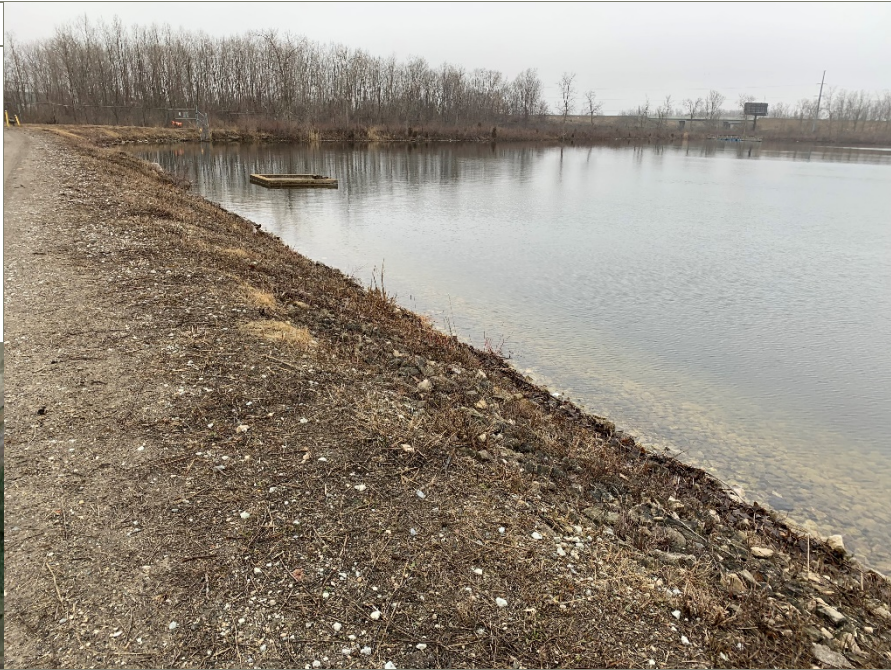
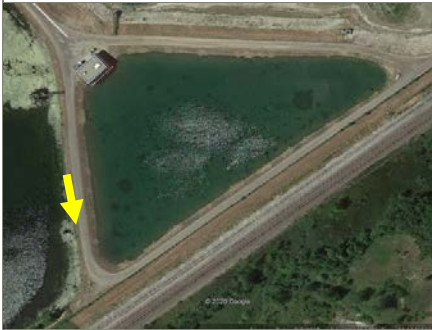
Photograph No. 27

The Lake Delta Transfer Structure, located between the Clear Water Pond and Lake Delta, appeared to be in good condition (Photos 27 and 28). Water from Lake Delta flows over the overflow weir and into the Clear Water Pond and is operated by a valve which appeared to be in good condition. At the time of inspection, stop logs were in place and level with the top of the overflow weir. The discharge pipe consists of 36-inch ductile iron pipe, equipped with square, (8-feet x 8-feet) concrete, anti-seep collars. The concrete and stop logs appeared to be in good condition. The pipe of the Lake Delta Transfer Structure is underground/submerged and could not be observed during the visual inspection. There was no evidence of settlement, sinkholes, or cracking in the area of the embankment above the pipe extending through the Clear Water Pond embankment.

Description:
Exterior slope of West Embankment and Lake Delta Transfer Structure.

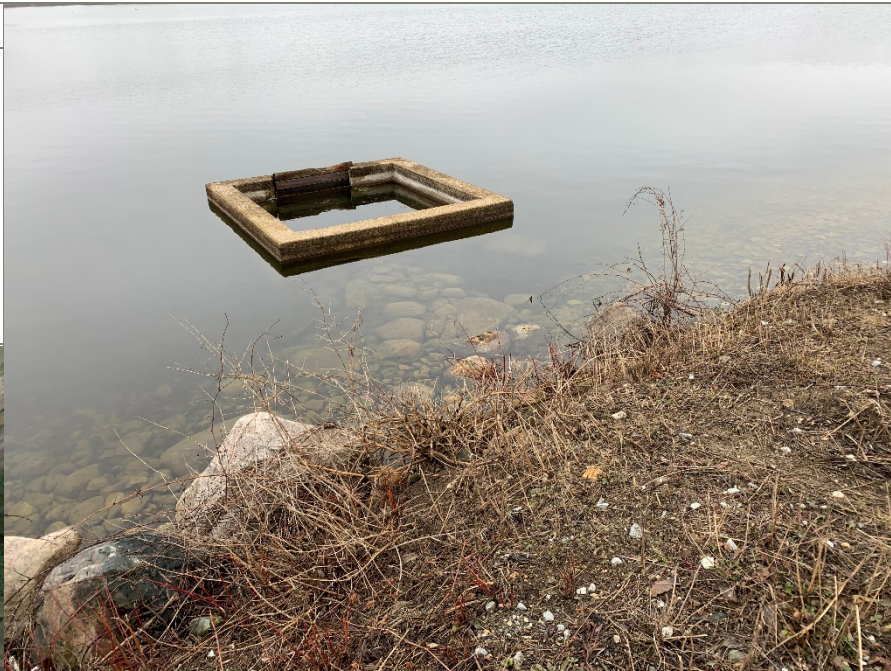
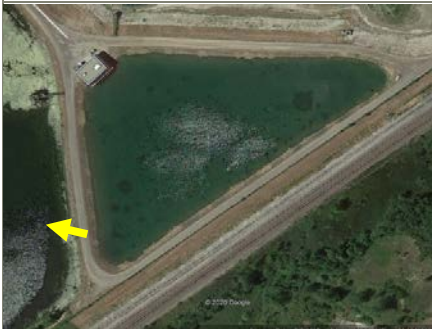
Photograph No. 28

Description:
Lake Delta Transfer Structure.
Note stop logs in place.
