Initial Inspection Report

For Compliance with the EPA Coal
Combustion Residuals (CCR) Rule
40 CFR 257.83(b)

Erickson Power Station –
Forebay and Retention Basin

August 10, 2020

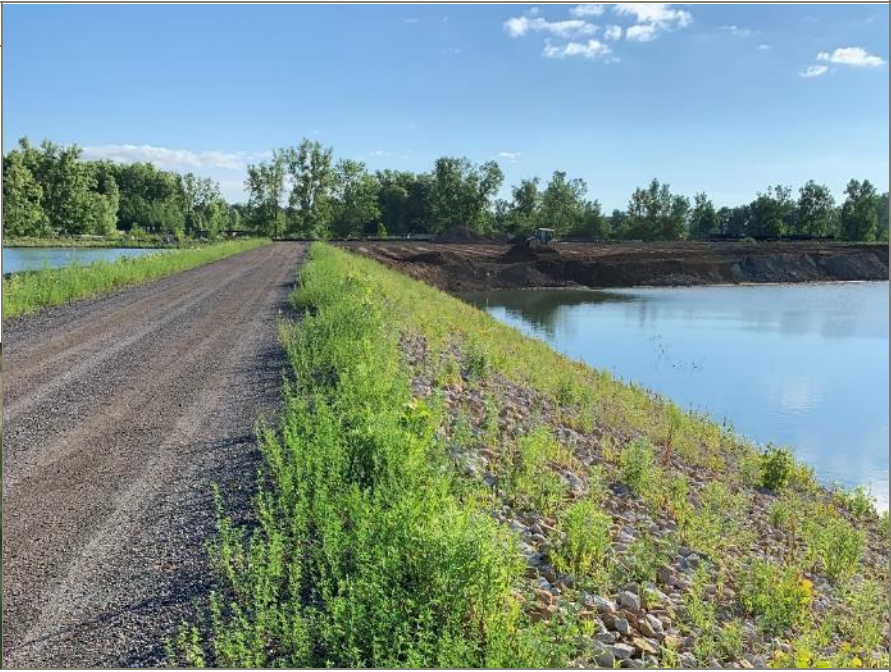
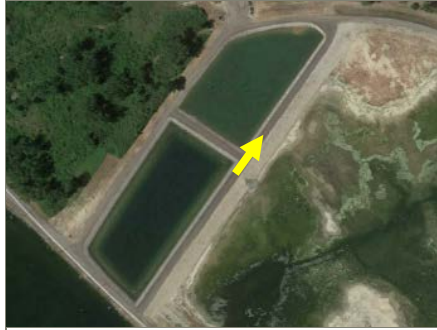
Photograph No. 1

The Southeast Embankment separates the Forebay and Retention Basin to the northwest and the Former Impoundment, which is closed, to the southeast. The Southeast Embankment appeared to be in good condition (Photos 1, 3, 6, 7, and 18), and no evidence

Description:
 Exterior slope of Southeast Embankment. Former Impoundment to the right of the photo and Forebay to the left of photo.

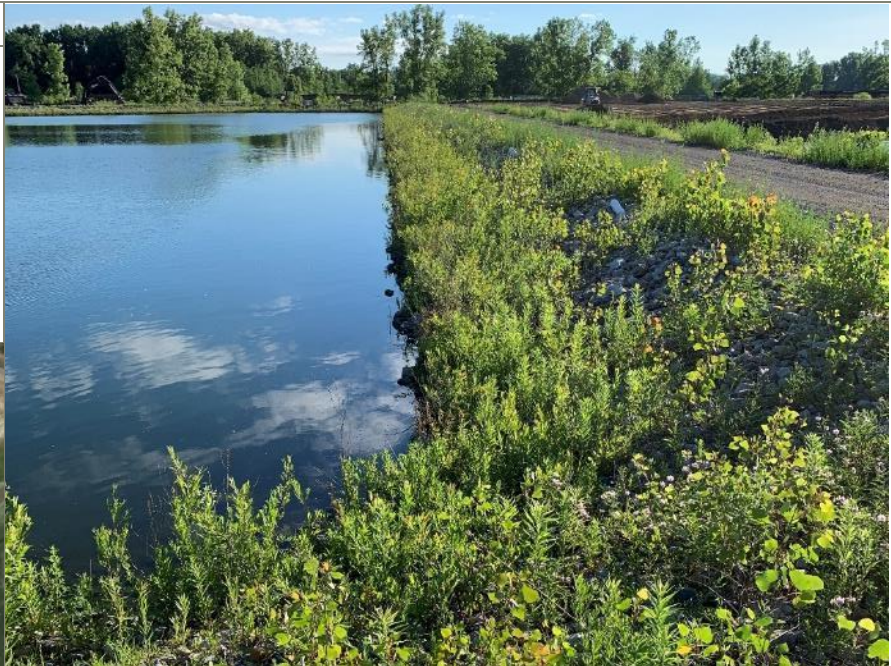
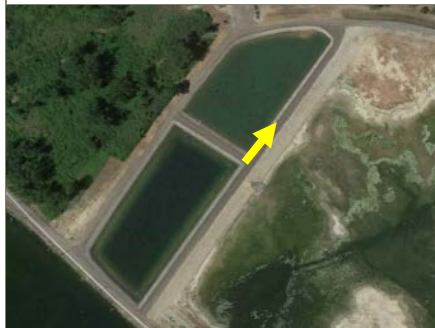
Photograph No. 3

Description:
Interior slope of Southeast Embankment, Forebay to left of photo. Note vegetation.

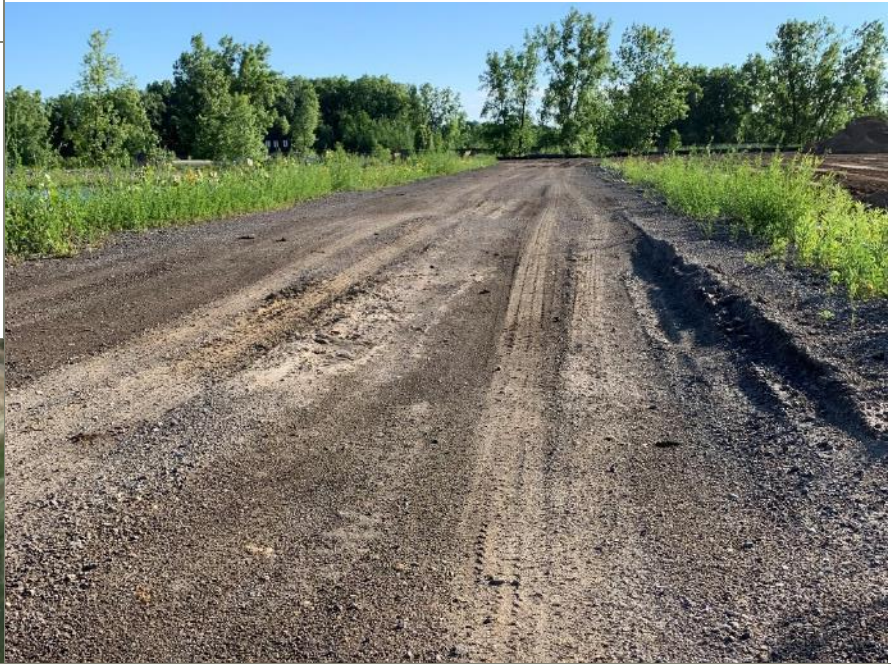
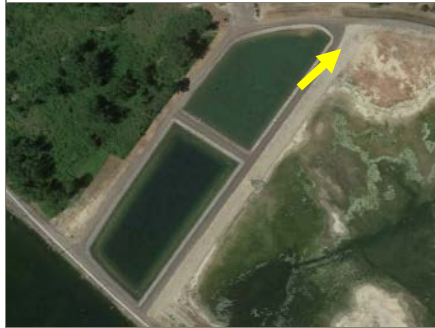
Photograph No. 7

- The crest of the embankment consisted of a gravelly/soil surface (Photos 1, 7, and 18). Minor rutting of the crest was observed, as seen in Photo 7.
- Rip-rap protects the interior and exterior slopes, which was in good condition.
- Vegetation has become overgrown on the interior and exterior slopes.
- The vents installed as part of the liner system were visible, appeared to be in good condition, and were free of debris.

Description:
Crest of Southeast Embankment.
Note rutting from vehicle traffic.

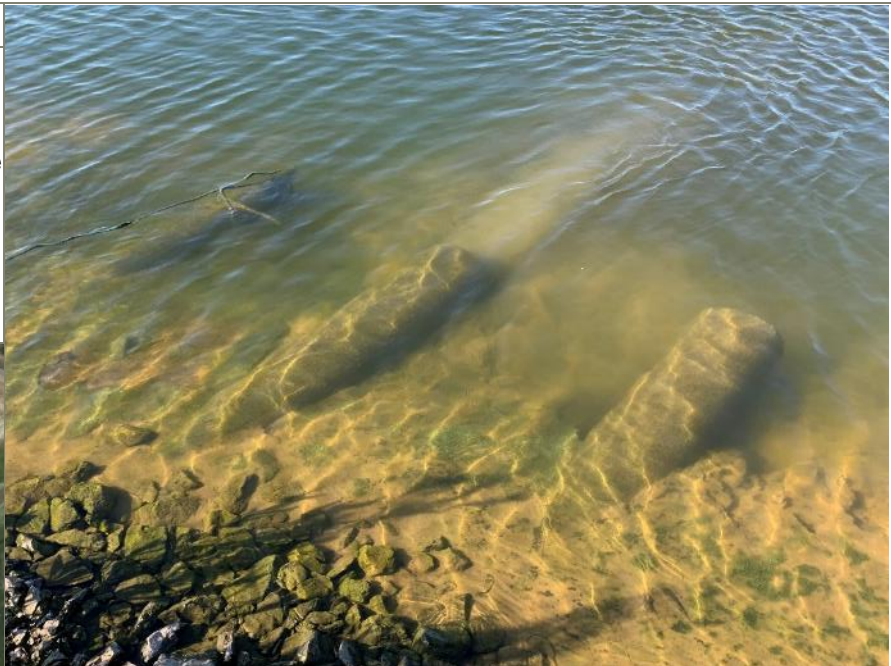
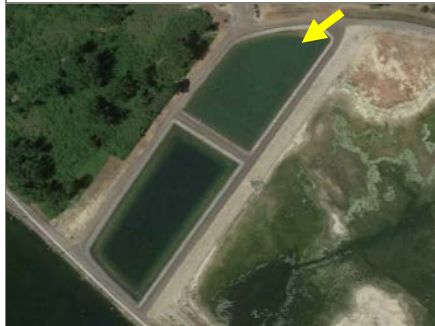
Photograph No. 8

The Forebay Influent Pipes, located at the northeast corner of the Forebay, appeared to be in good condition (Photos 8 through 10). The coal run-off pipe was plugged at the time of the visual inspection (Photo 9). The pipes were submerged and the interior could not be observed. There was no evidence of settlement, sinkholes, or cracking in the area above the pipes extending through the Northeast Embankment.

Description:
Forebay influent pipes. Note
influent pipe (far left) from coal
run-off was plugged by BWL at the
time of the inspection.

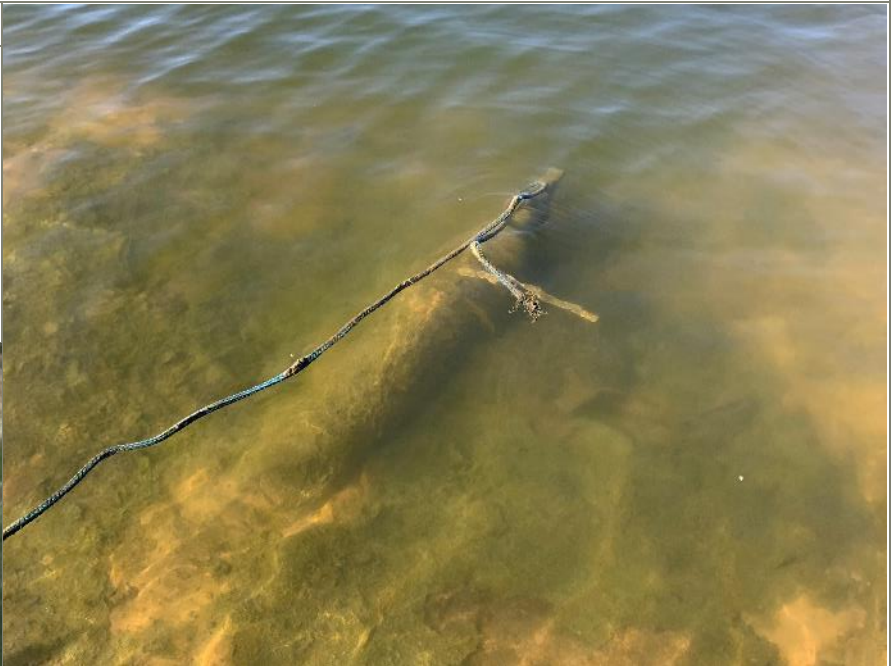
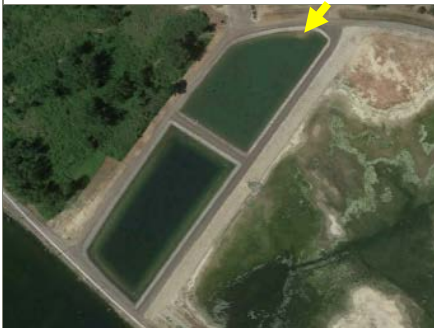
Photograph No. 9

Description:
Forebay influent pipe from coal run-off. Note pipe is currently plugged.

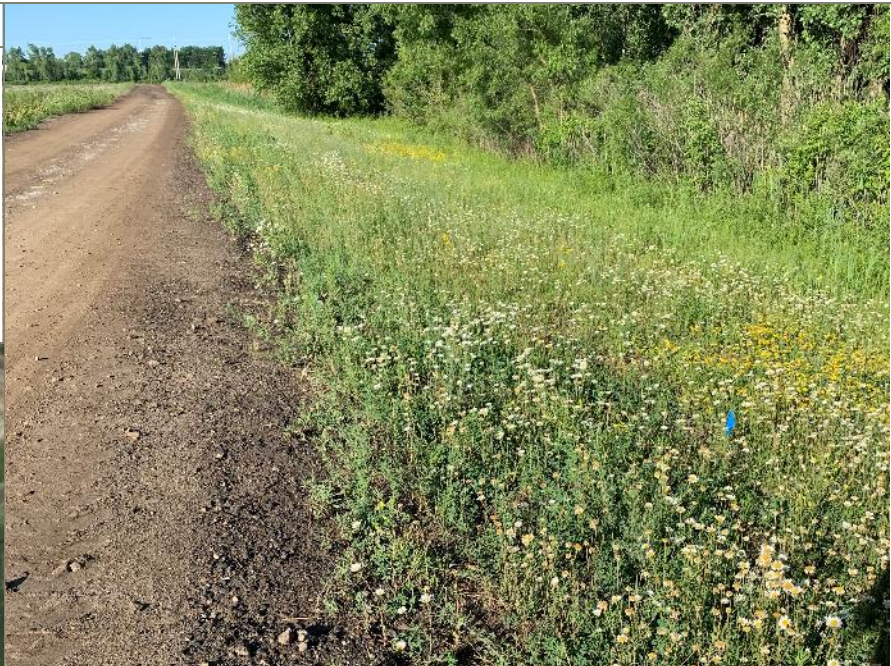
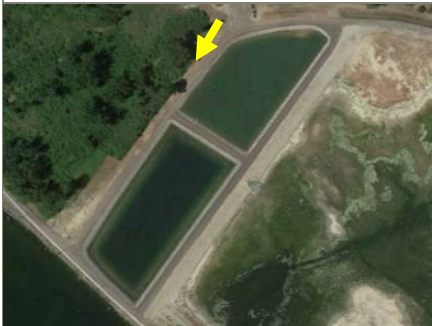
Photograph No. 12

- Rip-rap protects the interior slope and vegetation covers the exterior slope. The condition of the exterior slope was hard to assess due to the dense vegetation. The crest of the embankment consisted of a gravelly/soil surface.
- Vegetation has become overgrown on the interior and exterior slopes.

Description:
Exterior slope of Northwest Embankment. Note vegetation.

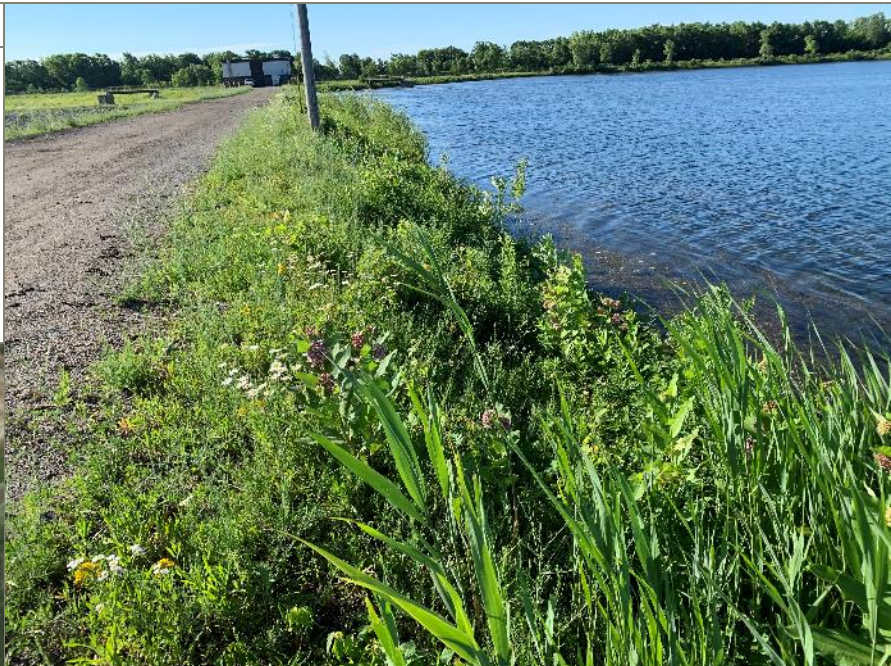
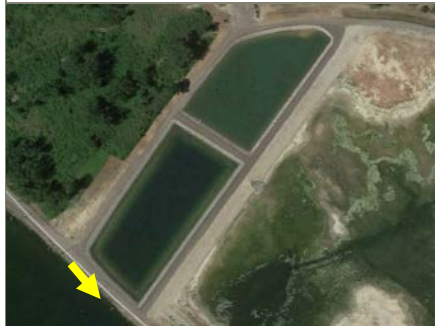
Photograph No. 16

- Rip-rap protects the interior slope and vegetation covers the exterior slope (adjacent to Lake Delta). The condition of the exterior slope was hard to assess due to the dense vegetation. The crest of the embankment consisted of a gravelly/soil surface (Photos 15 and 16).
- Vegetation has become overgrown on the interior and exterior slopes.

Description:
Exterior slope of Southwest
Embankment. Lake Delta to right
of photo. Note vegetation.

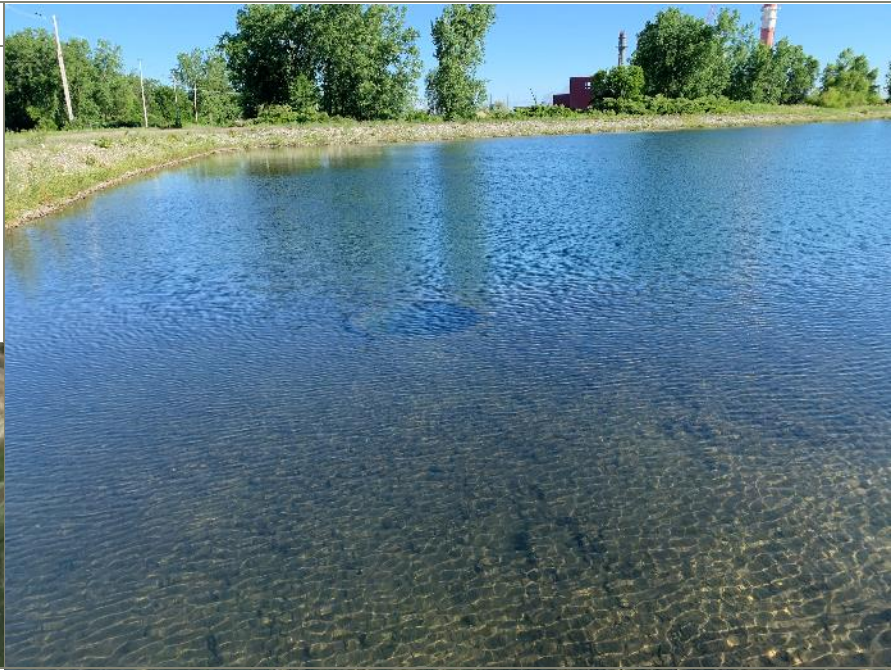
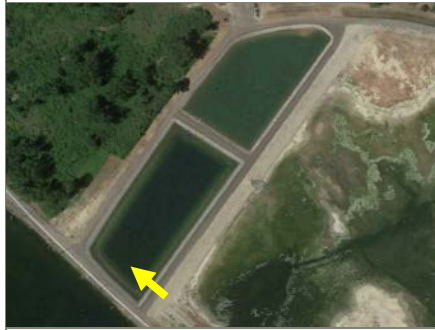
Photograph No. 19

The Retention Basin Overflow Structure was submerged but partially visible at the time of inspection and appeared to be in good condition (Photo 19). However, the trash rack installed to prevent debris from entering the overflow has been dislodged during a storm event and now rests near the bank of the Retention Basin (Photo 22 and 28).

Description:
Retention Basin Overflow
Structure. Note missing trash rack.

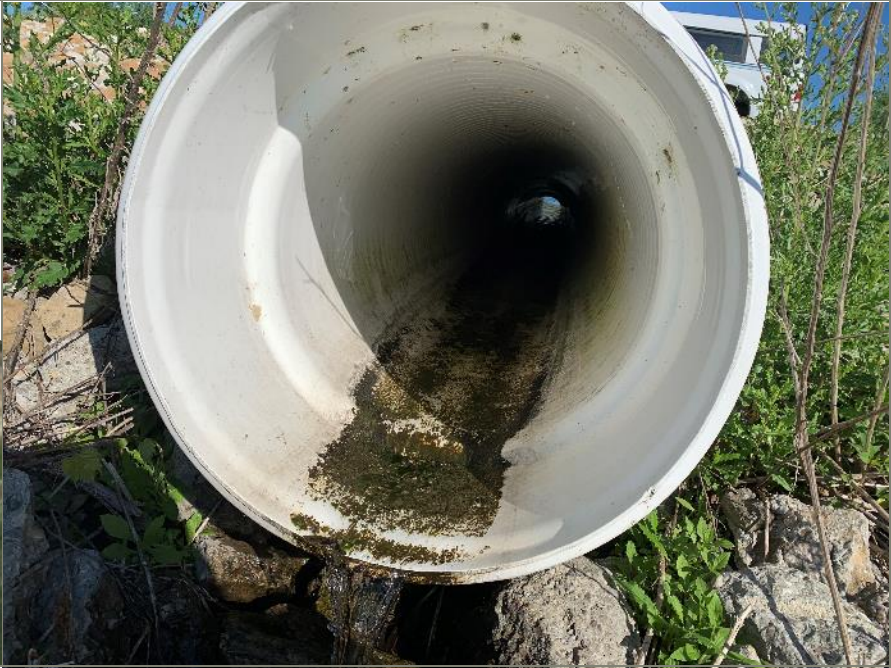
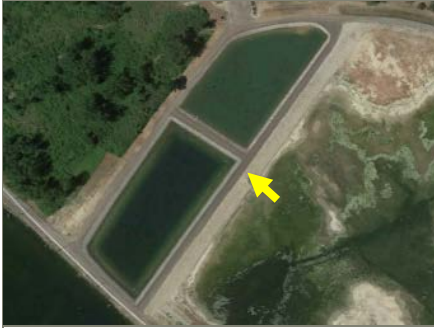
Photograph No. 21

The Former Impoundment Overflow appeared to be in good condition (Photos 20, 21, and 22). There was insignificant overflow entering the Former Impoundment Overflow from the Retention Basin at the time of the inspection (Photo 21). The pipe consists of 24-inch CPP and the interior was observable at the time of the inspection and was clear of obstructions. There was no evidence of settlement, sinkholes, or cracking in the area above the Former Impoundment Overflow extending through the Southeast Embankment.

Description:
 Former Impoundment Overflow
 (photo take from Former
 Impoundment side). Note water
 flowing from Retention Basin into
 Former Impoundment.

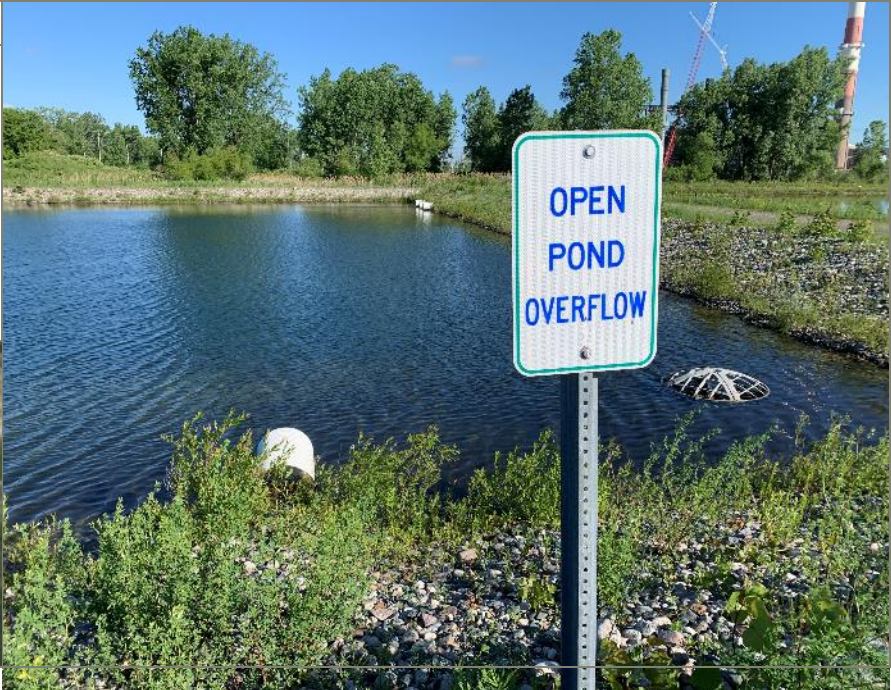
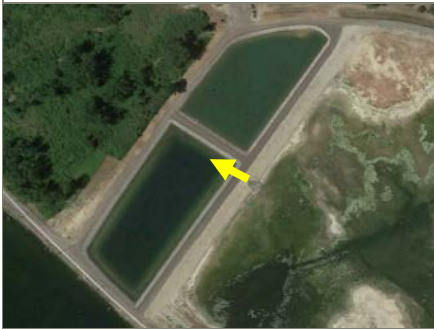
Photograph No. 22

Description:
 Former Impoundment Overflow
 (photo take from Retention Basin
 side) and sign. Note trash rack
 resting in pond. Trash rack
 became disconnected from the
 Retention Basin Overflow during a
 storm event.

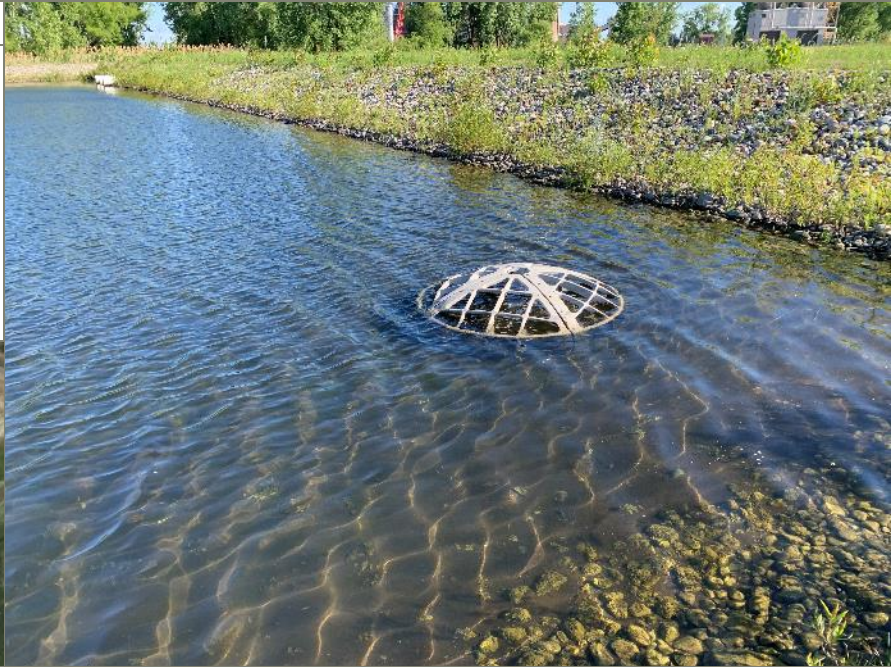
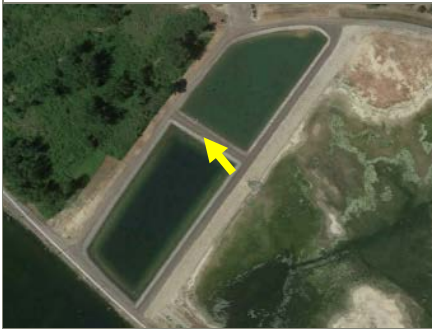
Photograph No. 28

Description:
Retention Basin Overflow trash rack resting in pond. Trash rack became disconnected from the Retention Basin Overflow during a storm event.
