Initial Structural Stability and Safety Factor Assessment

For Compliance with the EPA Coal
Combustion Residuals (CCR) Rule
40 CFR 257.73(d)
40 CFR 257.73(e)

Erickson Power Station – Clear Water Pond

June 12, 2020

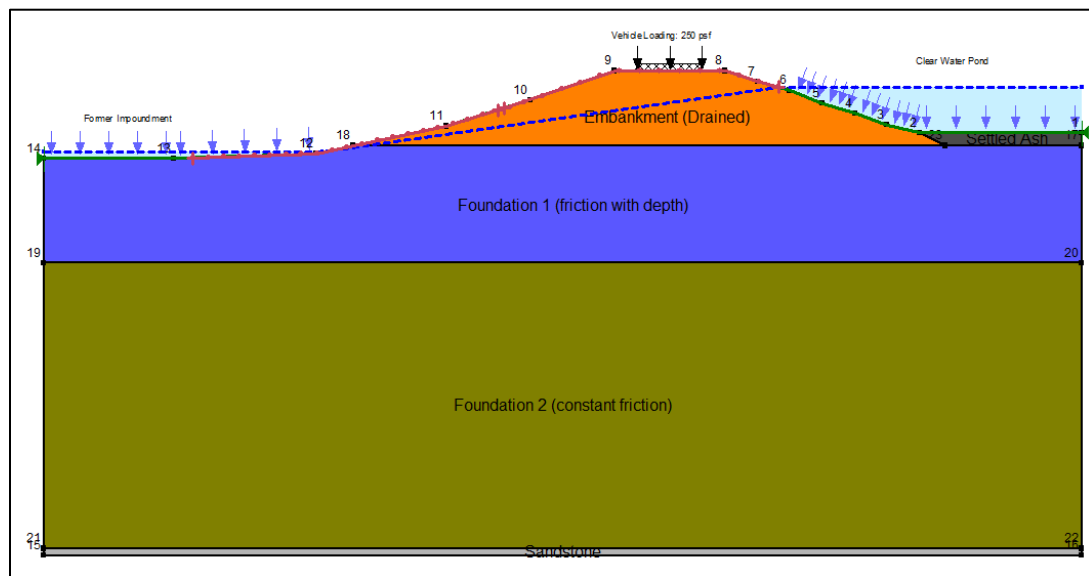
Figure 6. Section 1 Cross Section

The embankment stratigraphy is shown in Figure 6 and the material properties used for the slope stability analysis are presented in Table 3-2. The estimated material engineering properties were based on correlations with Standard Penetration Testing (SPT) performed in 1969 and HDR’s experience with similar conditions. The boring logs are provided in Attachment 1. HDR used undrained and drained shear strengths related to effective stresses, as recommended by the USACE.

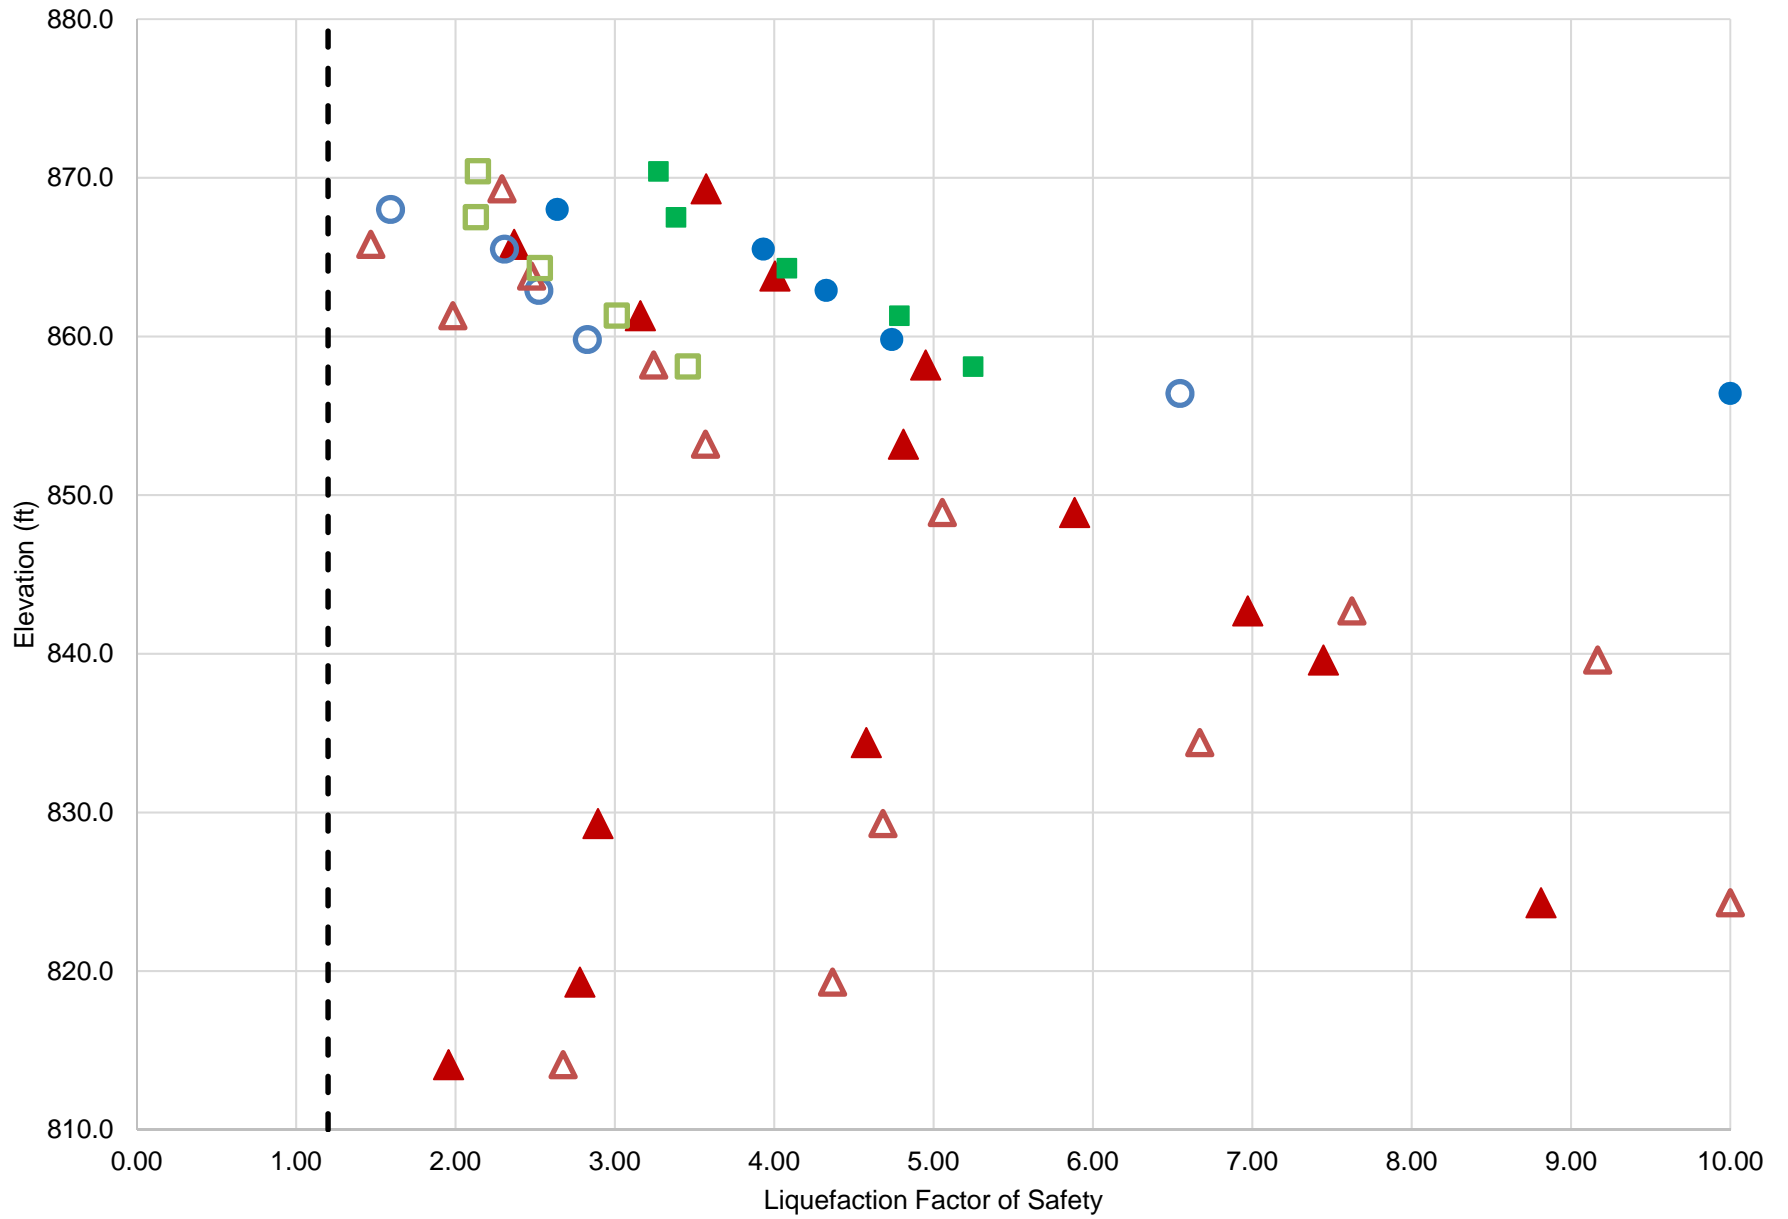
The static shear strength in the liquefaction-susceptible material is small. Therefore, K_α was taken equal to one for the purpose of this analysis. If the FS is greater than 1.2, soil is not susceptible to liquefaction. The calculated factor of safety against seismically-induced liquefaction is presented in on Page 4 of Attachment 2 and was calculated to be greater than 1.20 throughout the foundation depth. Considering that the embankment is classified as CL (USCS standard) and compacted material, the screening-level results indicate that the embankment and foundation soils are not susceptible to seismically-induced liquefaction for the seismic loading considered. In summary, the foundation was determined to be stable with respect to liquefaction for earthquakes up to the considered 2475-year return interval, which would have a PGA of 0.076g.

● AP-4 (Crest) ▲ AP-5 (Crest) ■ AP-6 (Crest) ○ AP-4 (Toe) △ AP-5 (Toe) □ AP-6 (Toe) - - SF=1.2

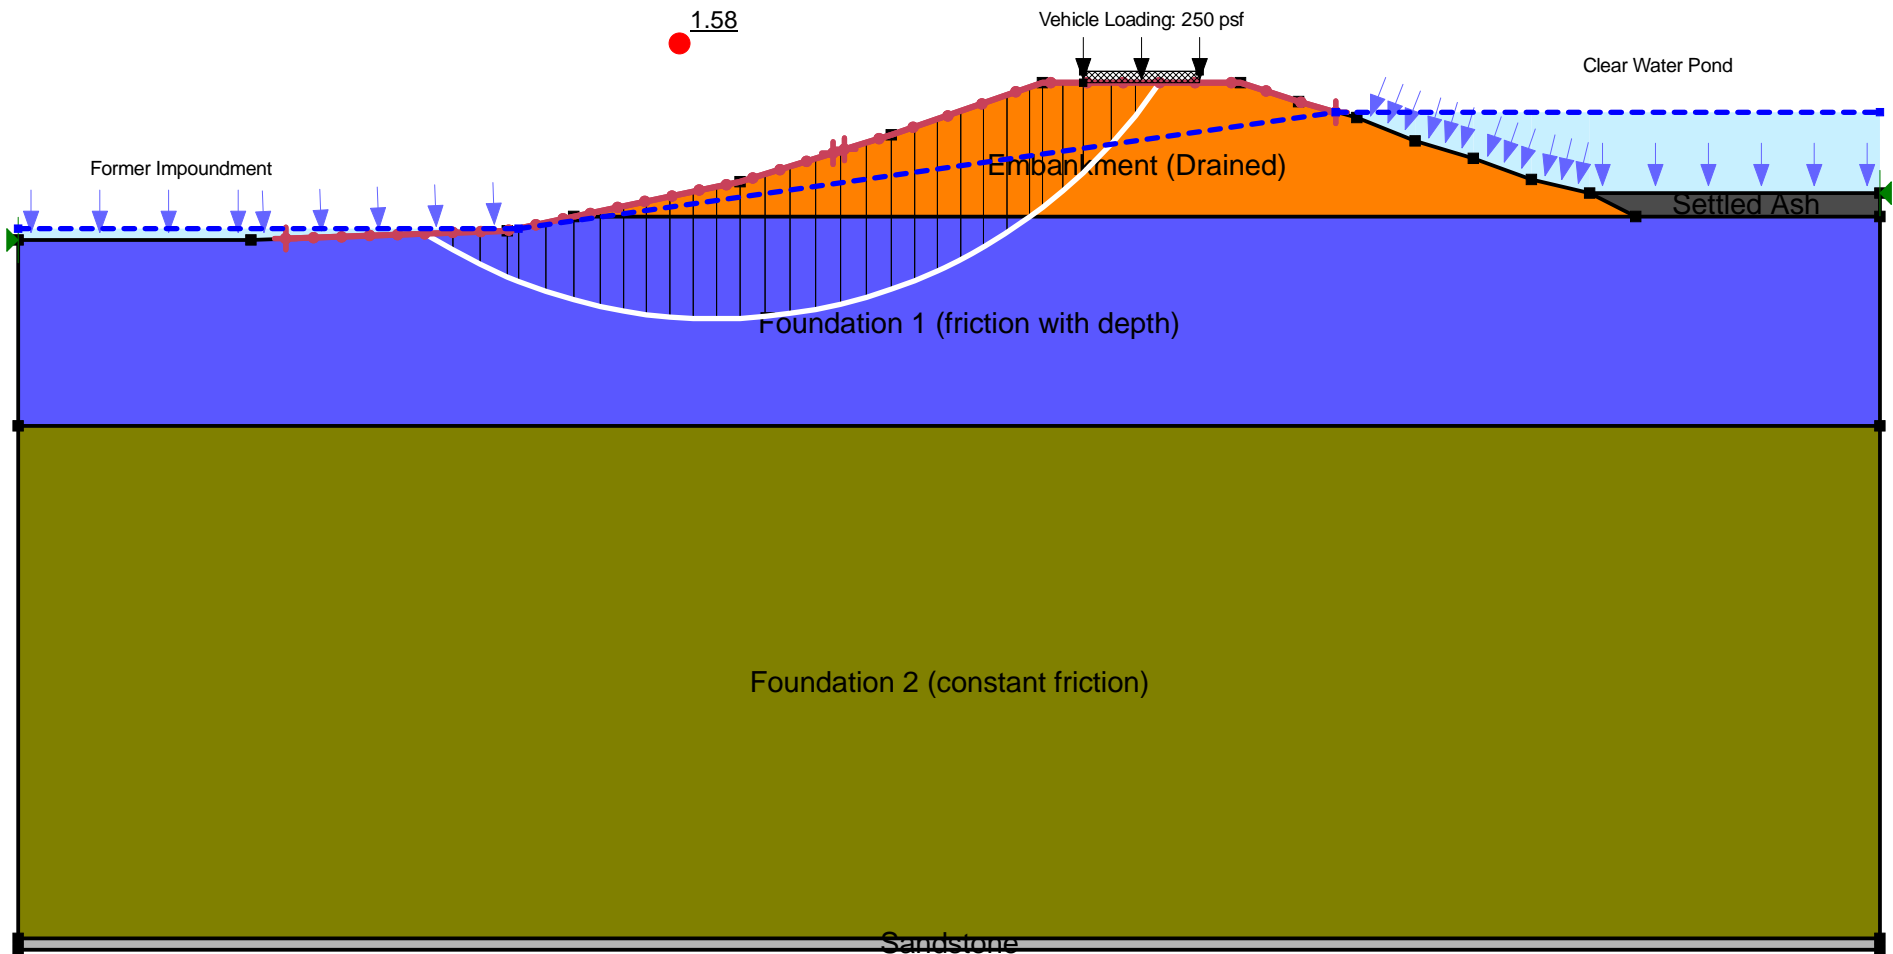
Name: Clear Water Pond - El. 882 feet
 Description: Normal Pool, Drained Conditions
 Method: Spencer
 FS: 1.58

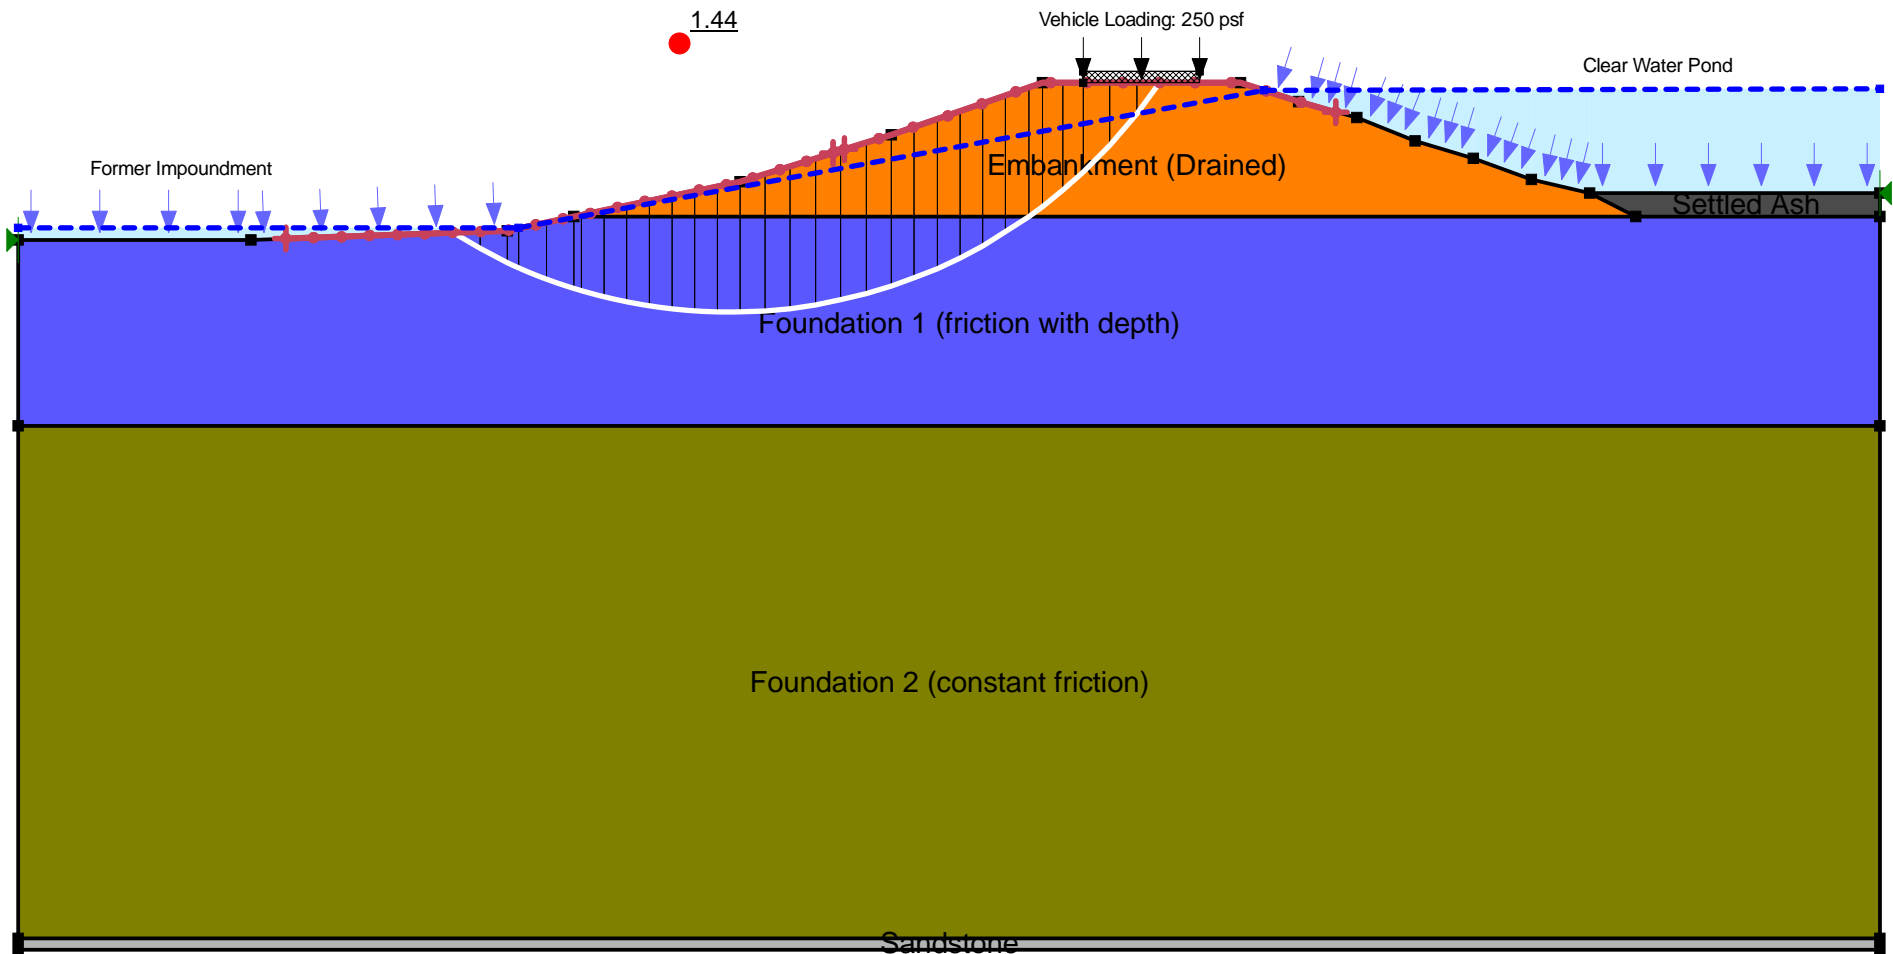
Name: Clear Water Pond - El. 884 feet
 Description: Surcharge Pool, Drained Conditions
 Method: Spencer
 FS: 1.44

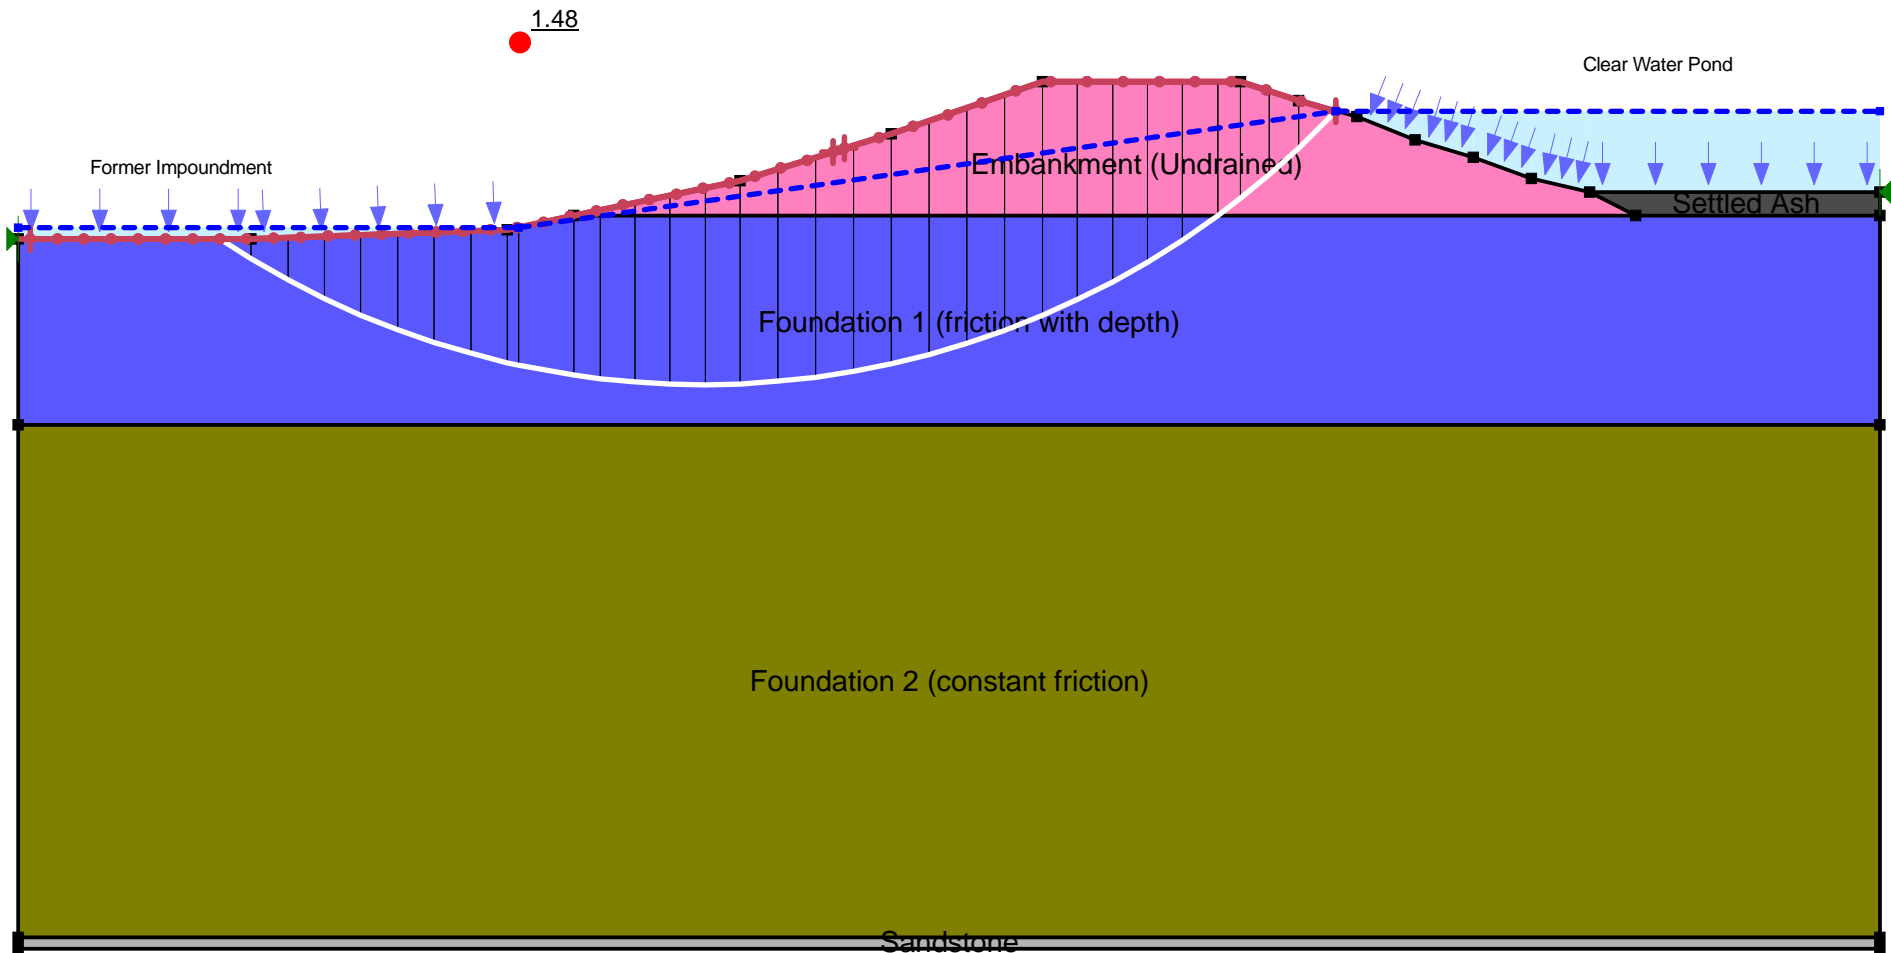
Name: Earthquake
 Description: Normal Pool, Undrained Conditions
 Method: Spencer
 FS: 1.48
