Initial Inspection Report

For Compliance with the EPA Coal
Combustion Residuals (CCR) Rule
40 CFR 257.83(b)

Erickson Power Station –
Forebay and Retention Basin

August 10, 2020

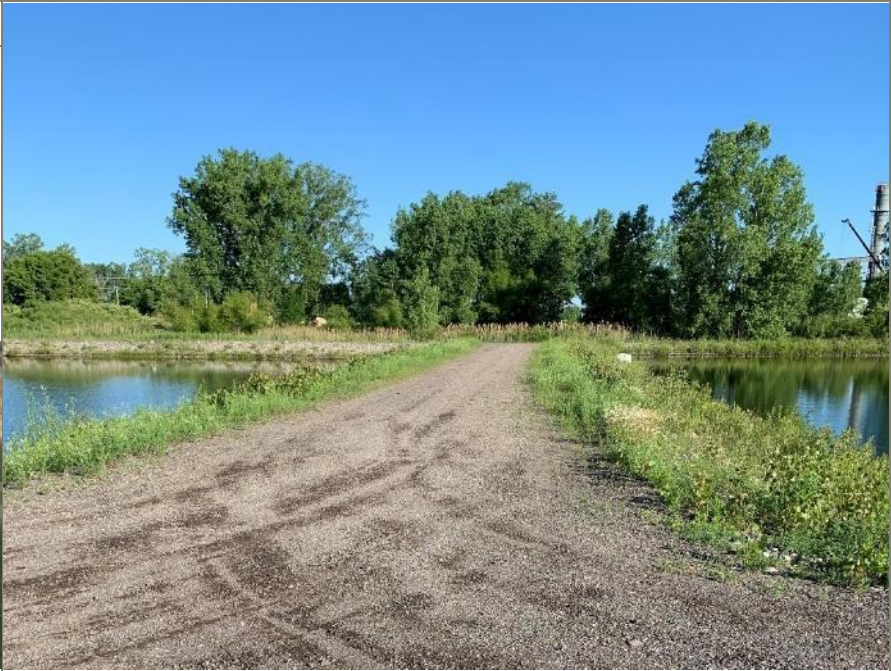
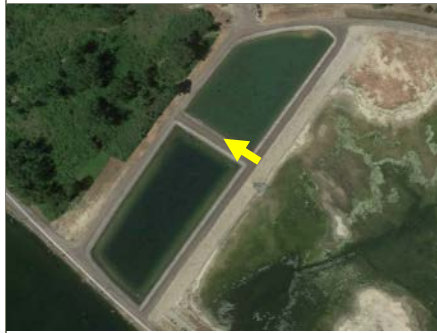
Photograph No. 2

Description:
 Central Embankment. Forebay to the right of photo and Retention Basin to the left of photo.

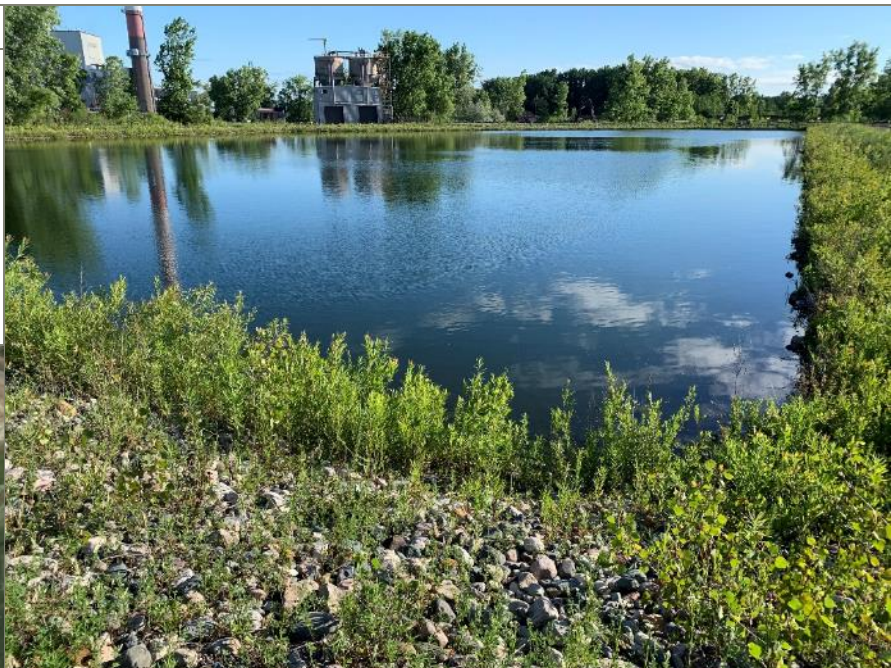
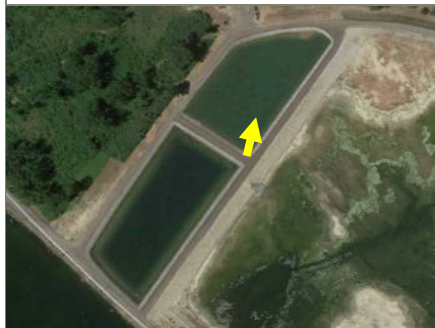
Photograph No. 4

Description:
Forebay with Hydro-Bins in the distance.

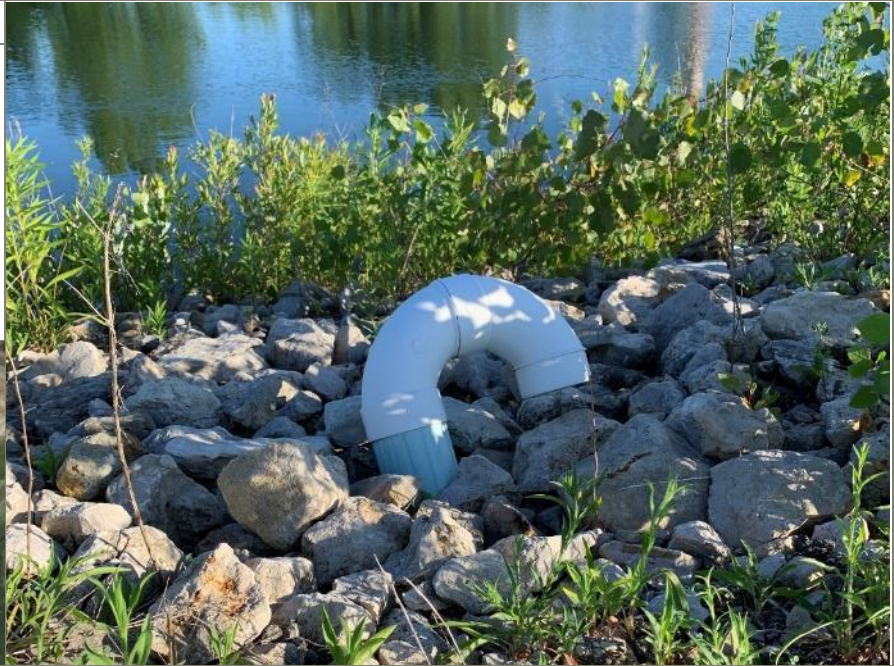
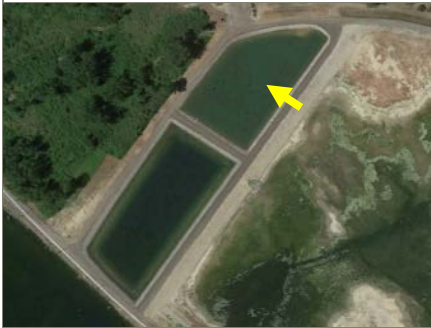
Photograph No. 5

- The crest of the embankment consisted of a gravelly/soil surface (Photos 1, 7, and 18). Minor rutting of the crest was observed, as seen in Photo 7.
- Rip-rap protects the interior and exterior slopes, which was in good condition.
- Vegetation has become overgrown on the interior and exterior slopes.
- The vents installed as part of the liner system were visible, appeared to be in good condition, and were free of debris.

Description:
 Vents for liner system underneath Forebay and Retention Basin. Vents are located approximately 40-foot intervals along perimeter embankment.

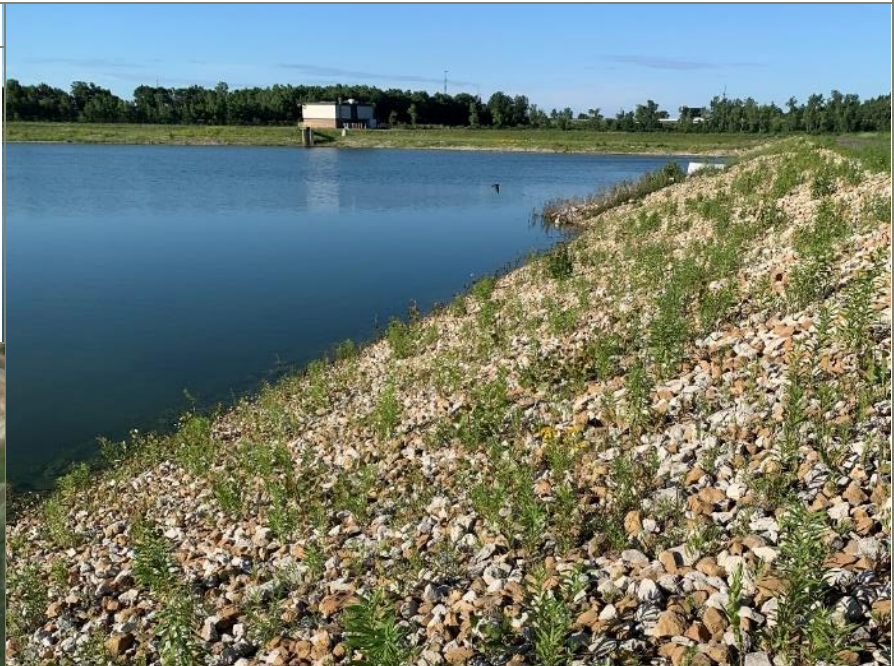
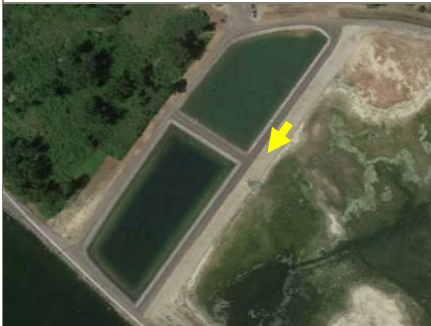
Photograph No. 6

The Southeast Embankment separates the Forebay and Retention Basin to the northwest and the Former Impoundment, which is closed, to the southeast. The Southeast Embankment appeared to be in good condition (Photos 1, 3, 6, 7, and 18), and no evidence

Description:
 Exterior slope of Southeast Embankment. Pump House at Clear Water Pond in the distance.

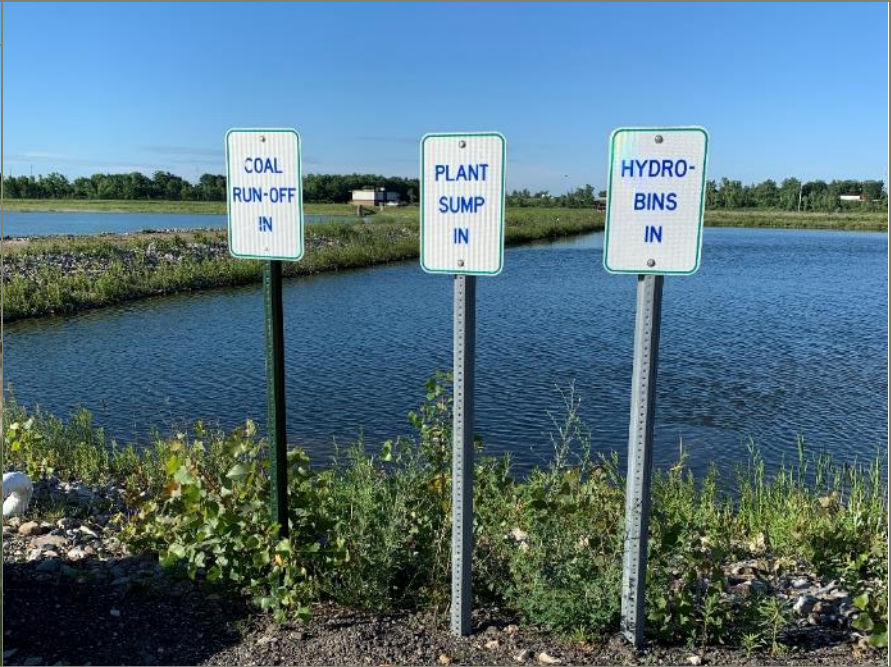
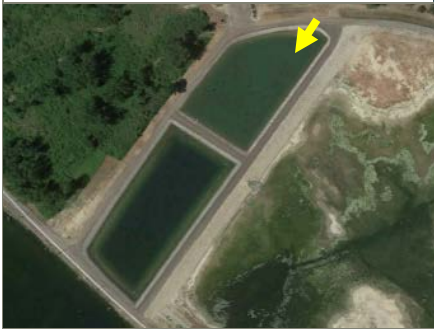
Photograph No. 10

The Forebay Influent Pipes, located at the northeast corner of the Forebay, appeared to be in good condition (Photos 8 through 10). The coal run-off pipe was plugged at the time of the visual inspection (Photo 9). The pipes were submerged and the interior could not be observed. There was no evidence of settlement, sinkholes, or cracking in the area above the pipes extending through the Northeast Embankment.

Description:
Signs indicating Forebay influent pipes. Forebay in the background.

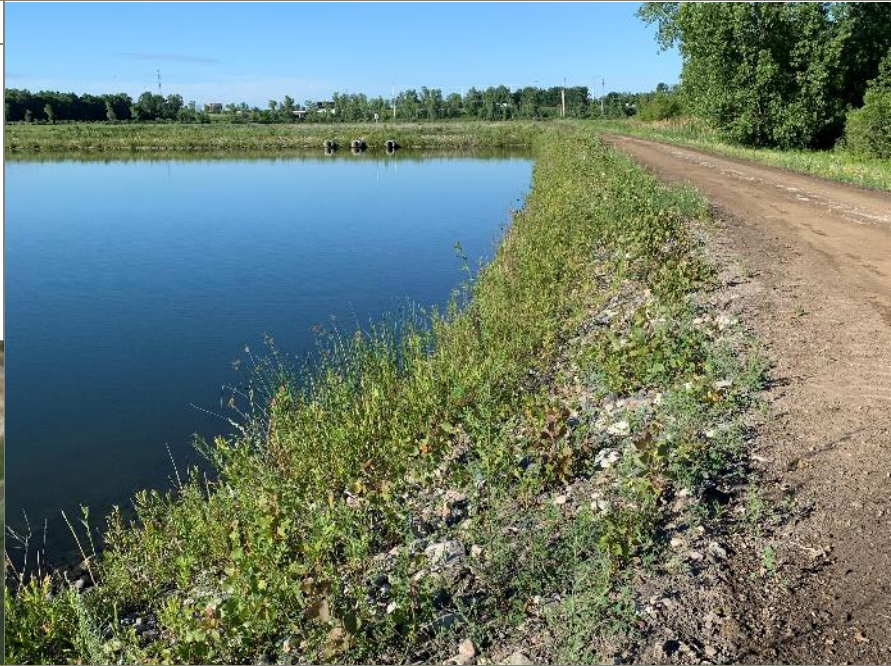
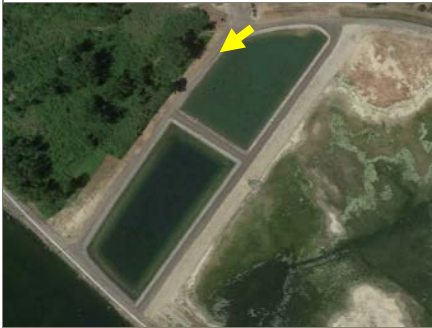
Photograph No. 11

The Northwest Embankment separates the Forebay and Retention Basin to the southeast and wooded areas to the northwest. The Northwest Embankment appeared to be in good condition (Photos 11, 12, and 14), and no evidence of movement, settlement, cracking, distress, erosion, seepage, animal burrows or other adverse conditions was observed in the crest and upstream and downstream slopes, except as noted herein.

Description:
Interior slope of Northwest Embankment with Forebay to the left.

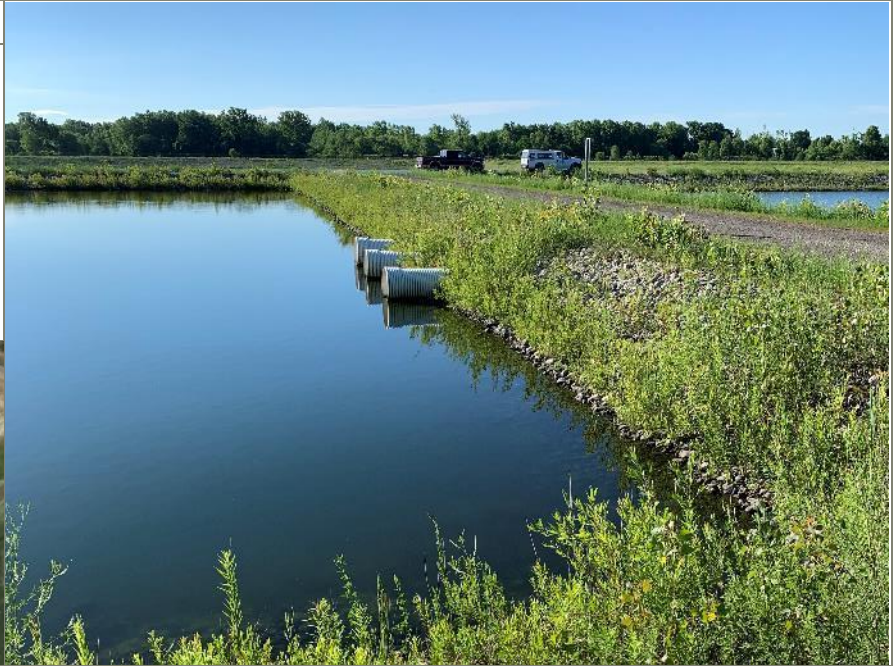
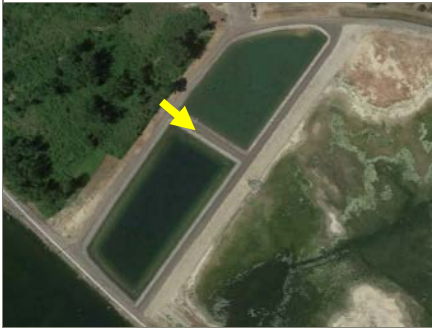
Photograph No. 13

The Forebay Overflow pipes, appeared to be in good condition (Photos 13, 24, 25, 26, and 27). The pipes were partially submerged and the interior could not be observed during the visual inspection. There was no evidence of settlement, sinkholes, or cracking in the area above the pipes extending through the Central Embankment.

Description:
 Central Embankment which separates Forebay and Retention Basin. Forebay overflow pipes (three) extending through the Central Embankment.

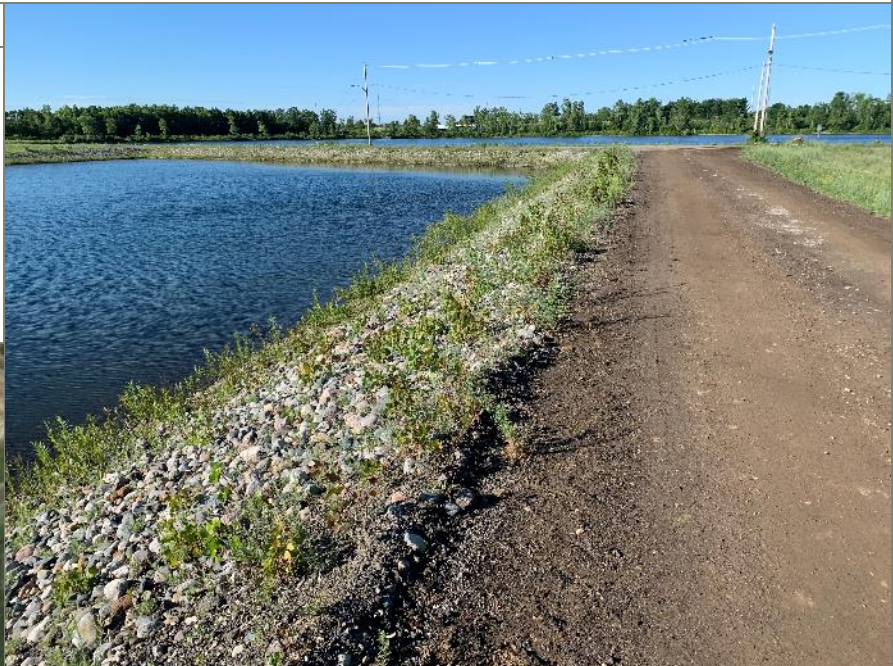
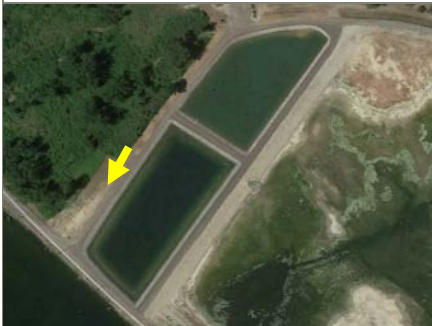
Photograph No. 14

Description:
 Southwest Embankment with Retention Basin to left of photo. Lake Delta in the background.

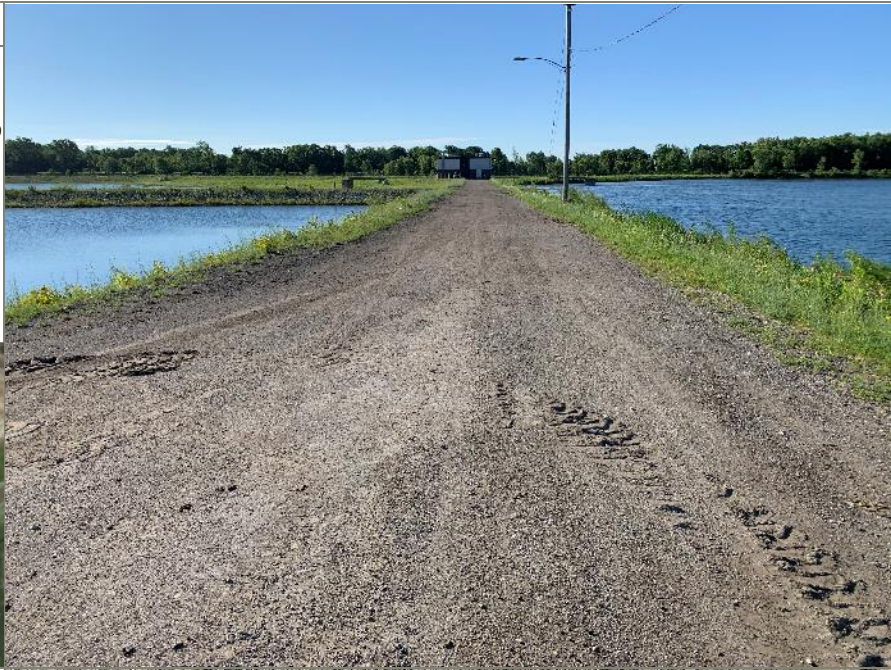
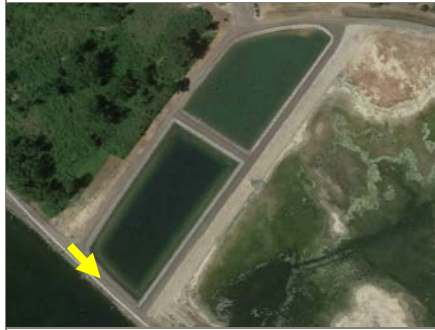
Photograph No. 15

The Southwest Embankment separates the Retention Basin to the northeast and Lake Delta to the southwest. The Southwest Embankment appeared to be in good condition (Photos 15 and 16), and no evidence of movement, settlement, cracking, distress, erosion, seepage, animal burrows or other adverse conditions was observed in the crest and upstream and downstream slopes, except as noted herein.

- Rip-rap protects the interior slope and vegetation covers the exterior slope (adjacent to Lake Delta). The condition of the exterior slope was hard to assess due to the dense vegetation. The crest of the embankment consisted of a gravelly/soil surface (Photos 15 and 16).
- Vegetation has become overgrown on the interior and exterior slopes.

Description:
Southwest Embankment.
Retention Basin to the left of photo
and Lake Delta to the right of
photo.

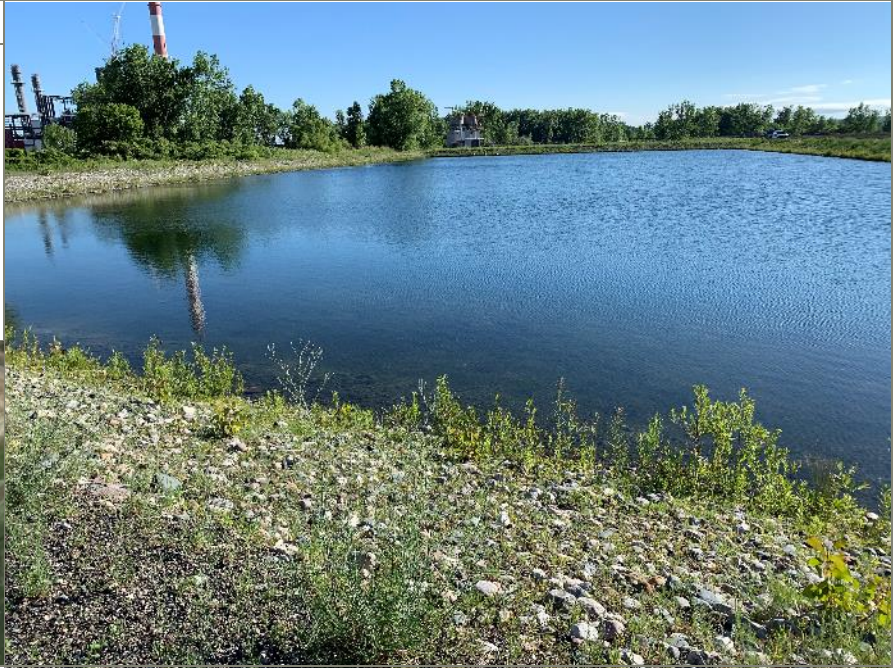
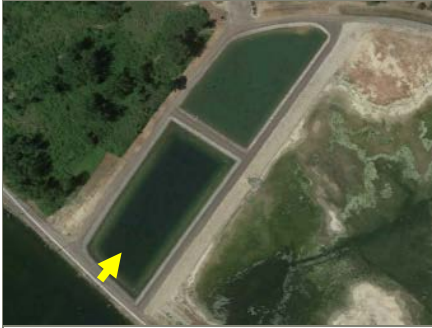
Photograph No. 17

Description:
View of Retention Basin from Southwest Embankment.

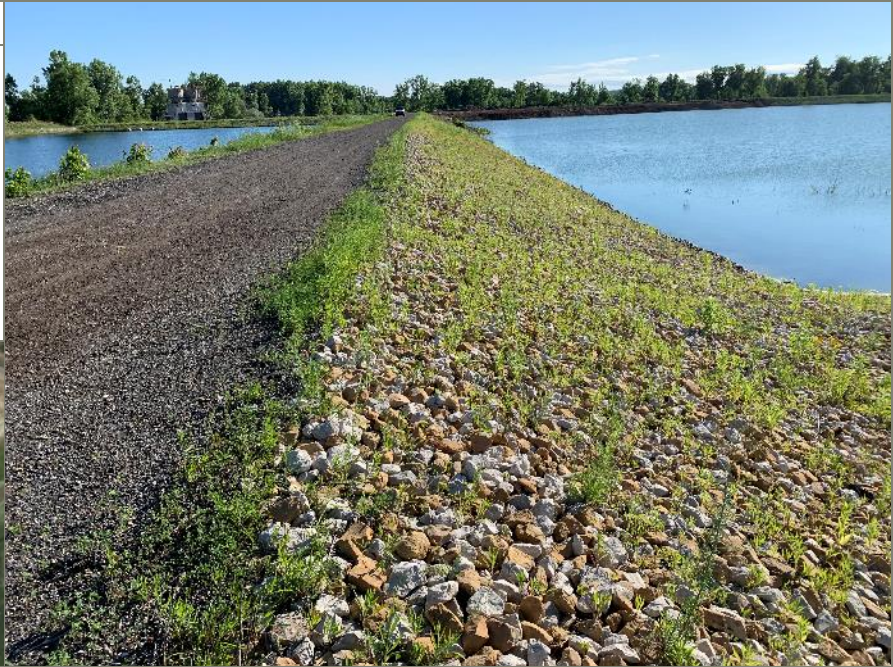
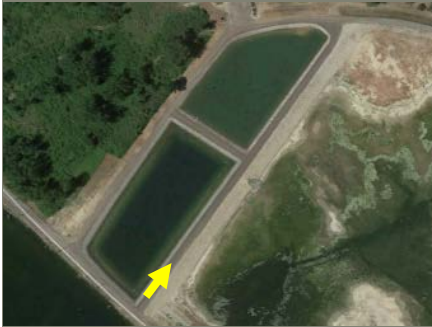
Photograph No. 18

Description:
Southeast Embankment. Former Impoundment to right of photo and Retention Basin to the left of photo.

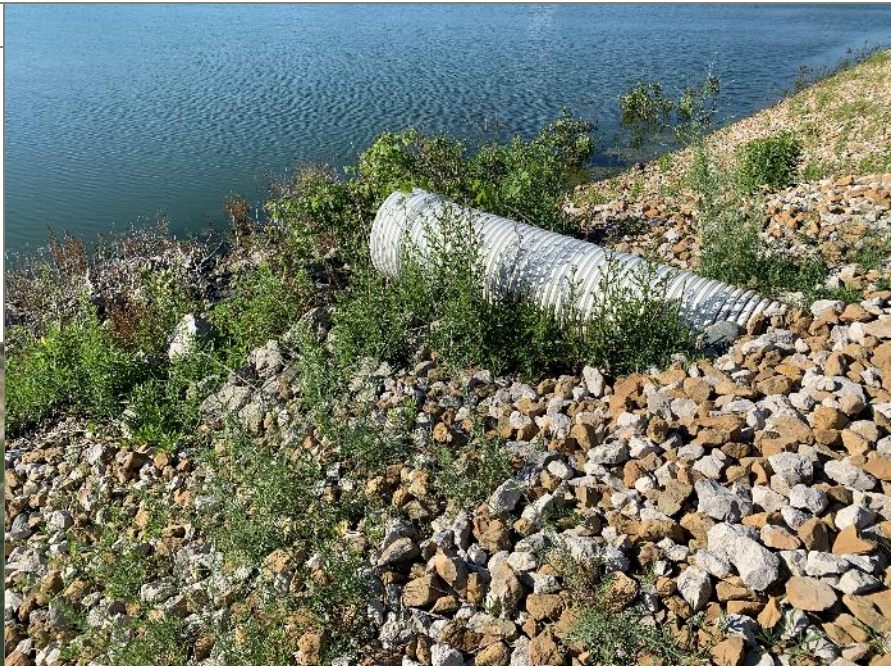
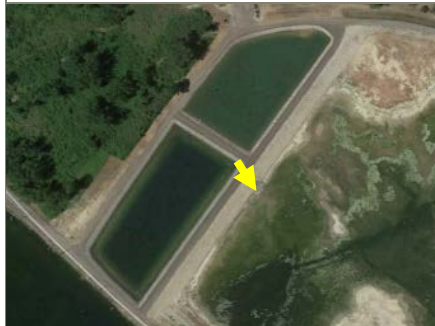
Photograph No. 20

The Former Impoundment Overflow appeared to be in good condition (Photos 20, 21, and 22). There was insignificant overflow entering the Former Impoundment Overflow from the Retention Basin at the time of the inspection (Photo 21). The pipe consists of 24-inch CPP and the interior was observable at the time of the inspection and was clear of obstructions. There was no evidence of settlement, sinkholes, or cracking in the area above the Former Impoundment Overflow extending through the Southeast Embankment.

Description:
Former Impoundment Overflow
through Southeast Embankment.

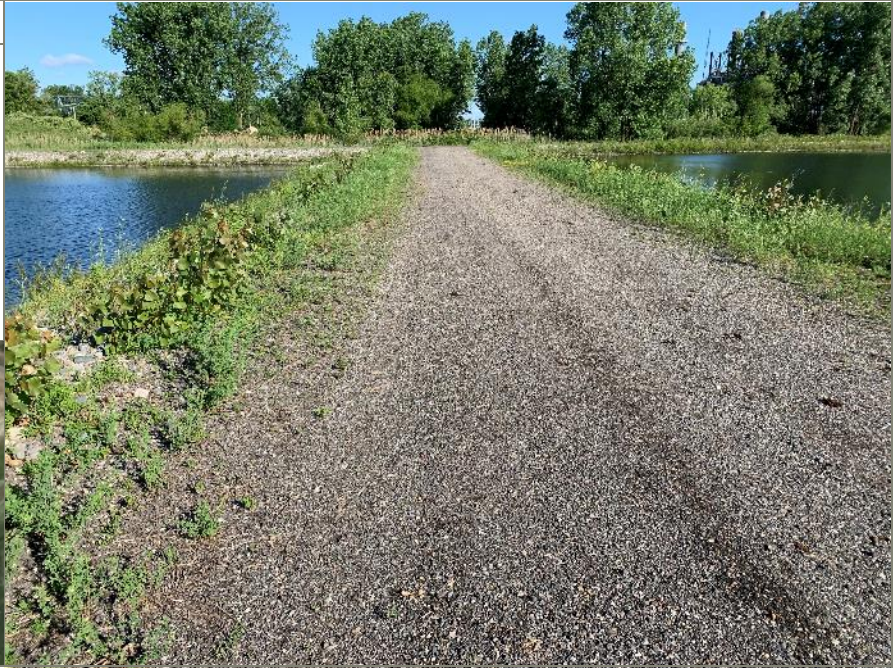
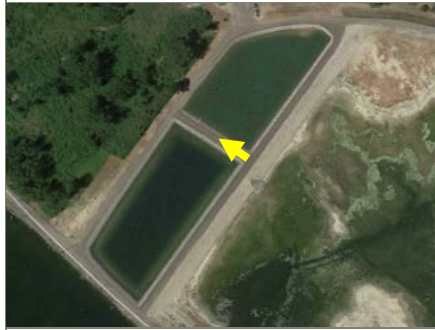
Photograph No. 23

Description:
Central Embankment. Forebay to the right of the photo and Retention Basin to the left of the photo.

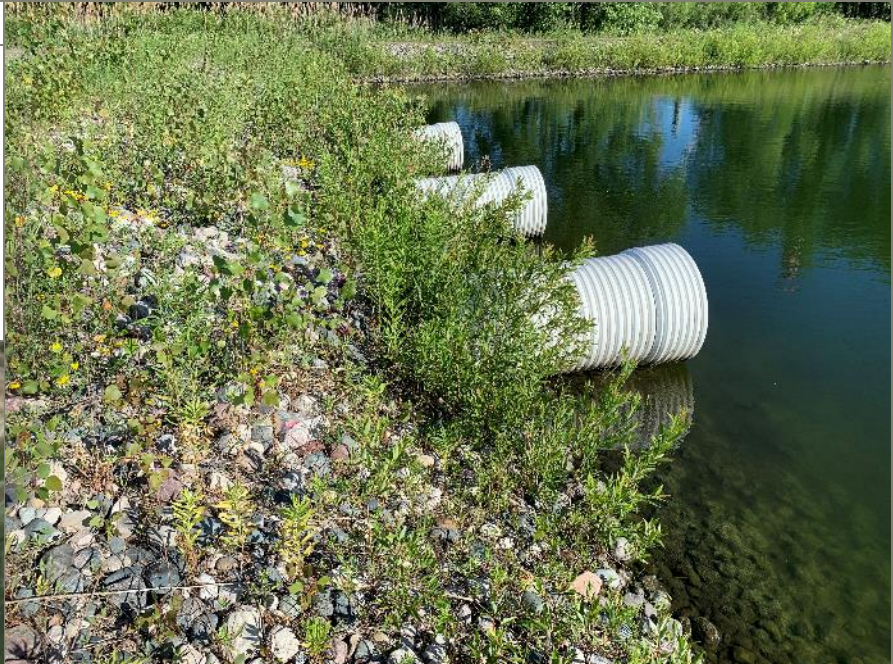
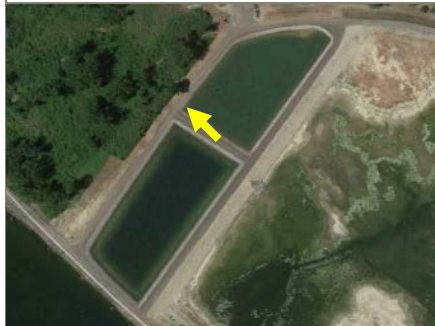
Photograph No. 24

Description:
Forebay overflow pipes discharging water from Forebay to Retention Basin.

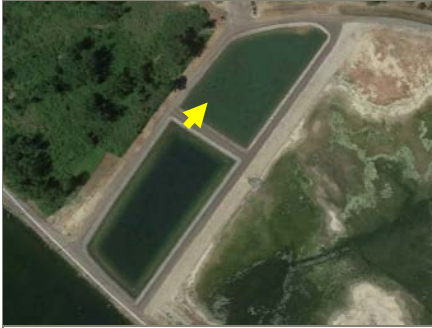
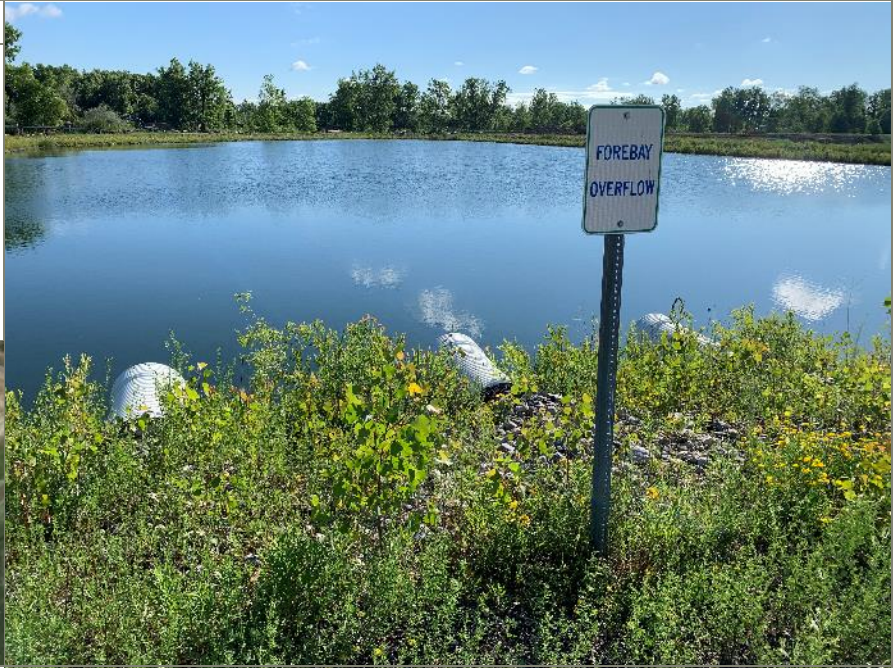
Photograph No. 25

Description:
 Forebay Overflow (influent) pipes and sign. Forebay in background.

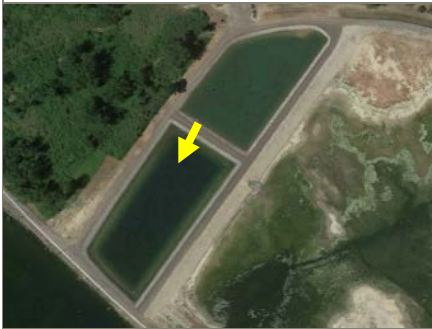
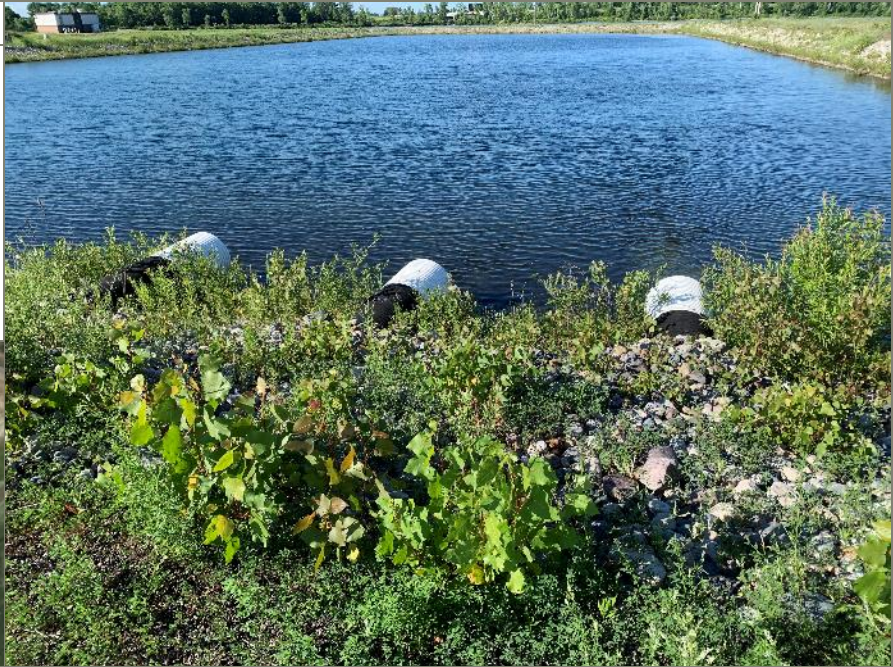
Photograph No. 26

Description:
 Forebay Overflow (effluent) pipes. Retention Basin in background.

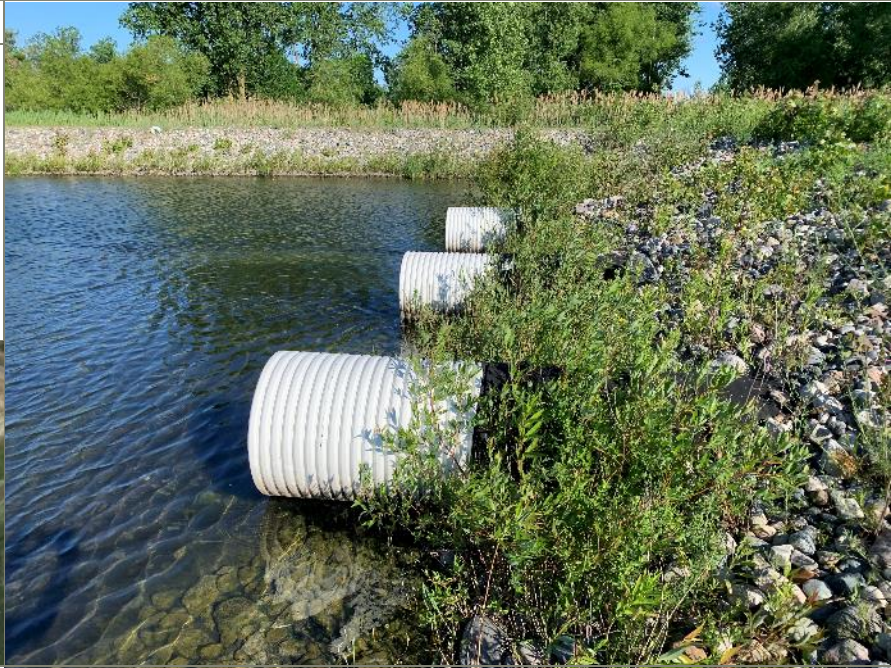
Photograph No. 27

Description:
Forebay Overflow (effluent) pipes.
Retention Basin to left of photo.
