## History of Construction

For Compliance with the EPA Coal  
Combustion Residuals (CCR) Rule  
40 CFR 257.73(c)

Erickson Power Station – Clear Water Pond

June 12, 2020

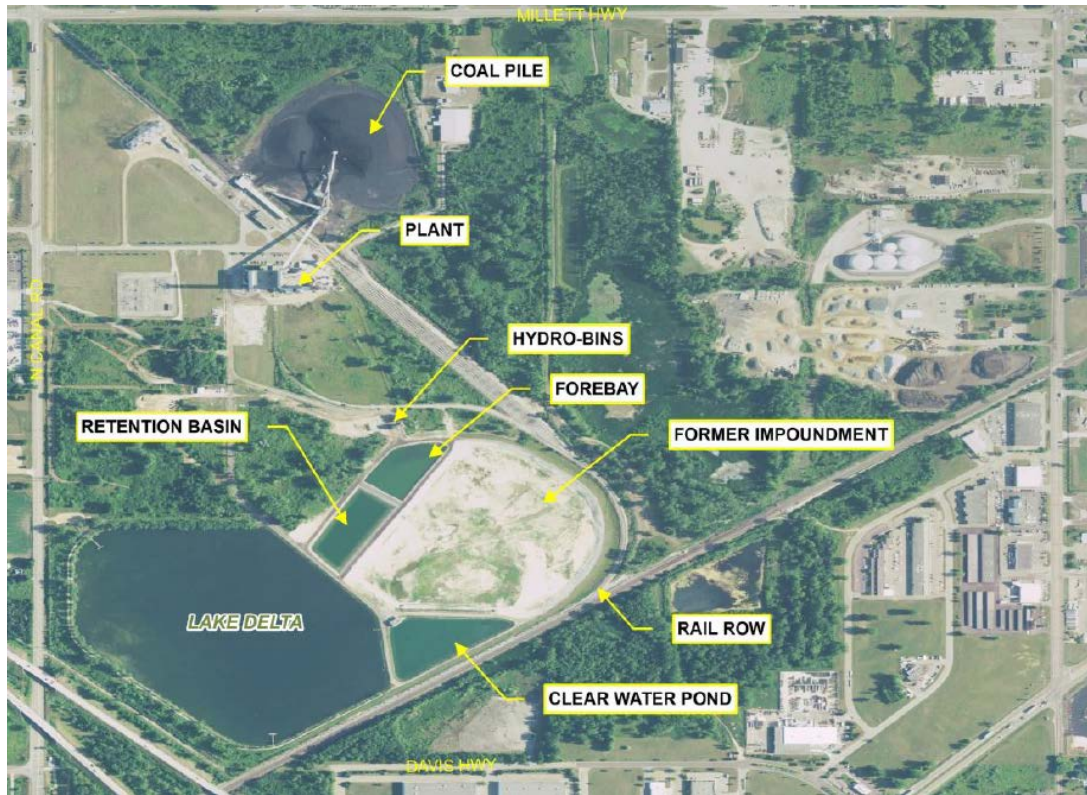
**Figure 2. Erickson Power Station Site Configuration**

Currently, the system consists of a series of three impoundments: the Forebay, Retention Basin, and Clear Water Pond. Figure 2 displays the Erickson Power Station site configuration, including the current impoundment system.

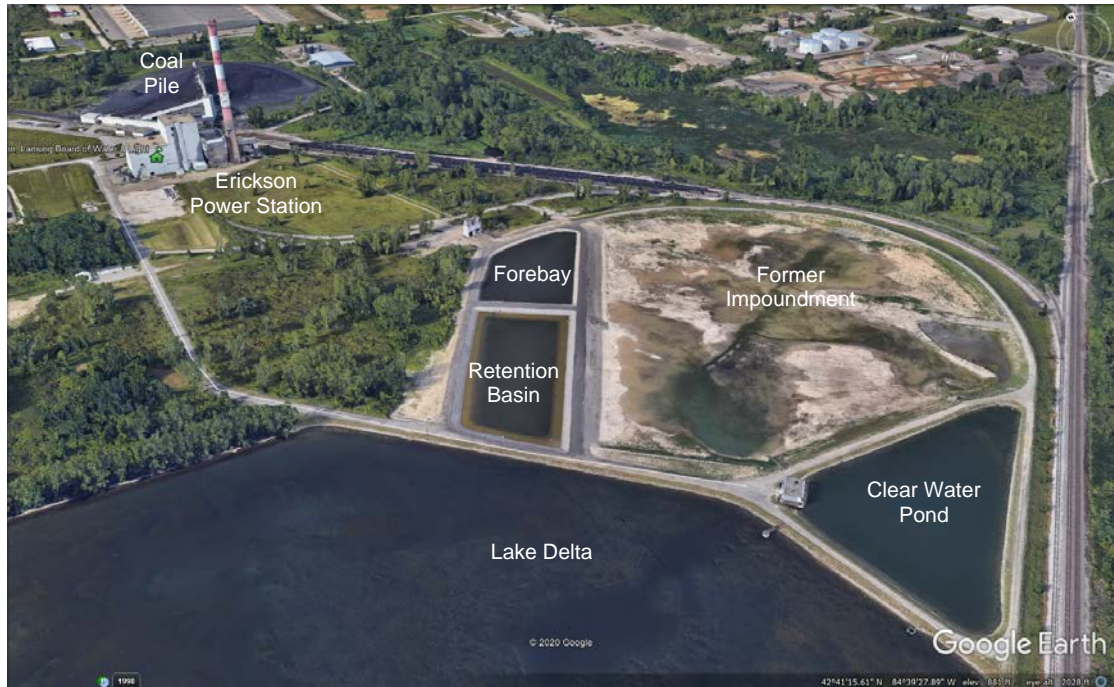
Figure 3. Google Earth Image of Impoundment System

Figure 3 presents a Google Earth view looking NNE, identifying the Clear Water Pond in relation to the impoundment system. Also viewable in Figure 3 is the Forebay, Retention Basin, Lake Delta, Former Impoundment, coal pile, and Erickson Power Station.

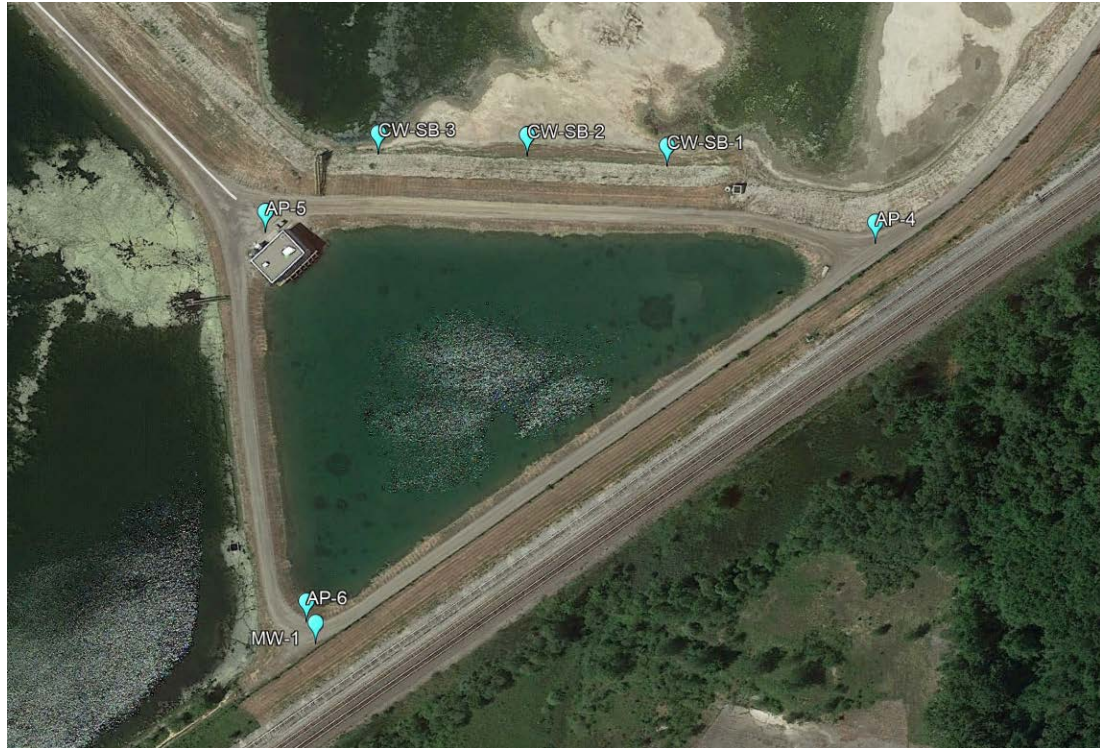
**Figure 5. Approximate Boring/Monitoring Well Locations at Clear Water Pond**

As part of the previous subsurface investigations, three borings (AP-4 through AP-6), three geoprobe borings (CW-SB-1 through CW-SB-3), and one monitoring well (MW-1) were performed/installed in the vicinity of the Clear Water Pond. The approximate boring and monitoring well locations are shown on Figure 5. The borings logs and monitoring well log are provided in Attachment 2.

In 2019 and 2020, HDR installed six monitoring wells for Erickson Power Station as part of the Hydrogeologic Characterization of the site to monitor the groundwater across the Erickson Power Station impoundment system. One of these monitoring well was installed through the south corner embankment of the Clear Water Pond as shown previously in Figure 5. The installation log of MW-1 is provided in Attachment 2.
